# **Type B Accident Investigation Board Report**

**May 8, 2004, Exothermic Metal Reaction Event  
During Sodium Transfer Activities  
East Tennessee Technology Park  
Oak Ridge, Tennessee**

**June 2004**

**Oak Ridge Operations Office  
U.S. Department of Energy**

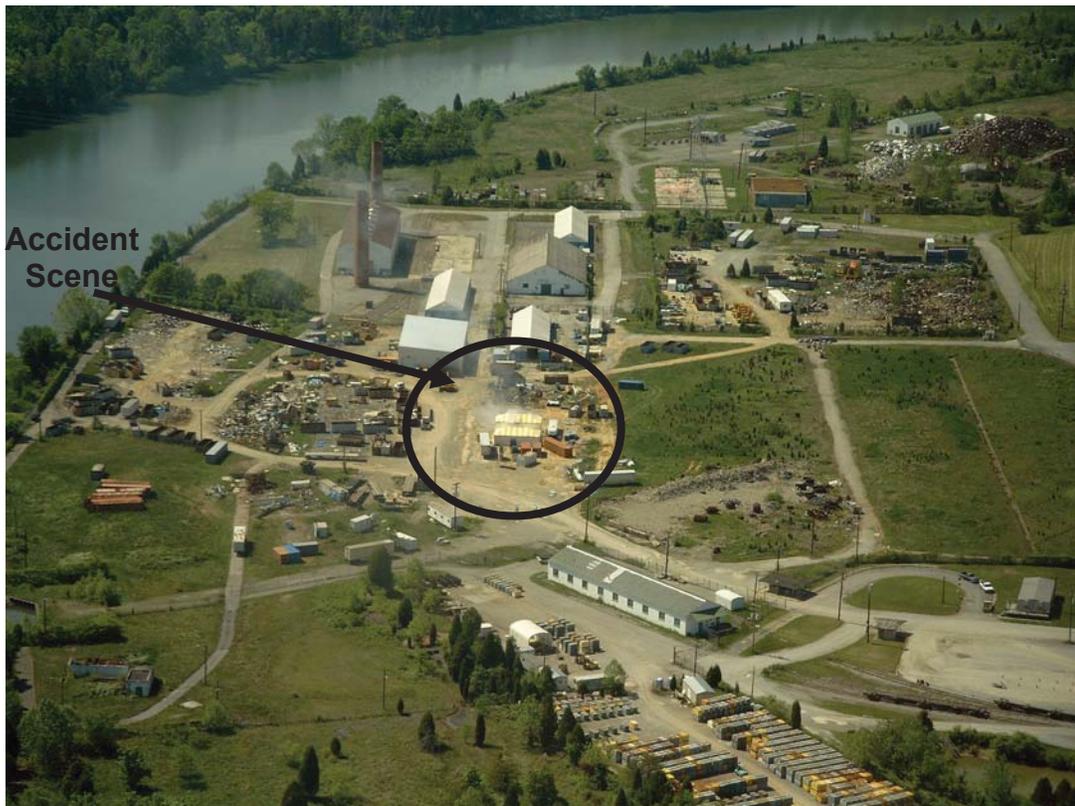
Figure 2-1. Overview of the Accident Scene

Commodore personnel were using the hot box to heat a shield consisting of sodium metal encased in an aluminum shell on May 8, 2004, on the property that Toxco subleased from CROET located at ETTP in Oak Ridge, Tennessee. The shield was being heated to liquefy the sodium for transfer to DOT-approved containers for shipment. The heating process began on May 5, 2004, in a hot box constructed for this purpose and continued through the morning of May 8. At approximately 10:00 am on May 8, as the sodium was being heated, Commodore personnel standing nearby heard a “pop” and a “whoosh” sound. At approximately 11:00 am, this was followed by additional noise and visual observance of material leaking from the hot box near the bottom of the side entrance door. The Commodore operators attempted to build a dam with Class D extinguishing agent to keep the flow of sodium from reaching the standing rainwater on the ground, but their efforts were unsuccessful. The sodium subsequently contacted standing rainwater, and an exothermic reaction occurred. At 11:24 am, Toxco personnel contacted the ETTP Park Shift Superintendent (PSS) and reported that they had a sodium fire at their facility. The ETTP Fire Department, Security, and Health Physics personnel were dispatched to the scene. Figure 2-1 provides an overview of the accident scene.

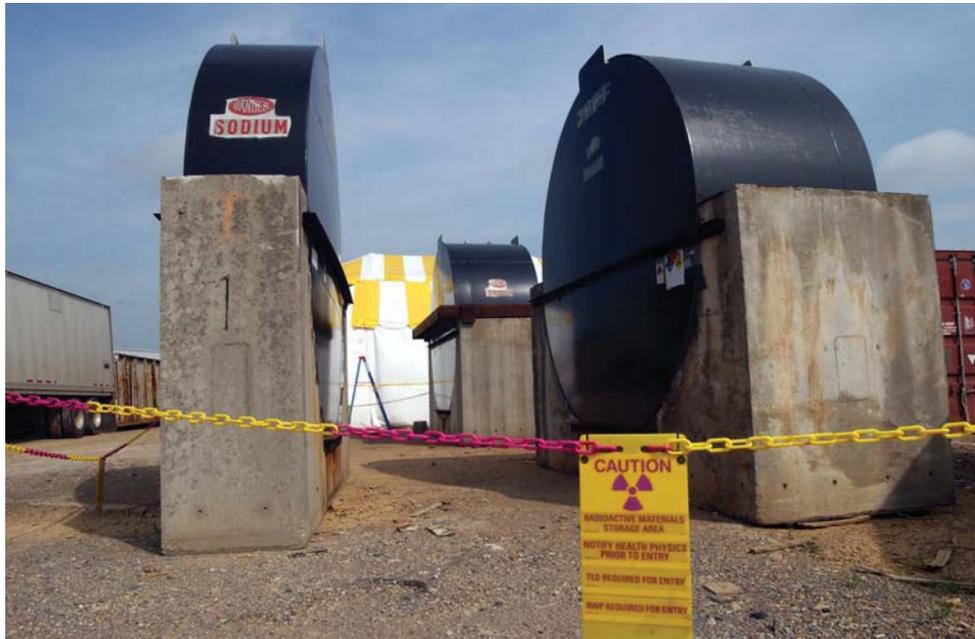
**Figure 2-2. Large Sodium Shields**

long and 2.5 or 5.0 feet thick. The volume of the shield that was being processed (a 2.5-foot-thick shield) is 237 cubic feet, and it contained approximately 14,000 pounds of sodium when the heat transfer process began. The combined shield and cradle were covered with a matching concrete cap that was removed before transport to ETTP and subsequent heating.

The concrete was used to minimize the neutron leakage from the sodium shields during the Tower Shielding Facility's experiments and to hold the shield in place. There are two 2 1/2-inch fill caps in the top of the shield and a single 1-inch drain cap in the bottom. Two 3-inch angle iron supports are located at the 6-inch and 5-foot levels of the faceplates of the shield and are connected to the concrete cradle. Commodore chose a 2.5-foot-thick shield (IE 40113) for processing on May 5, 2004.

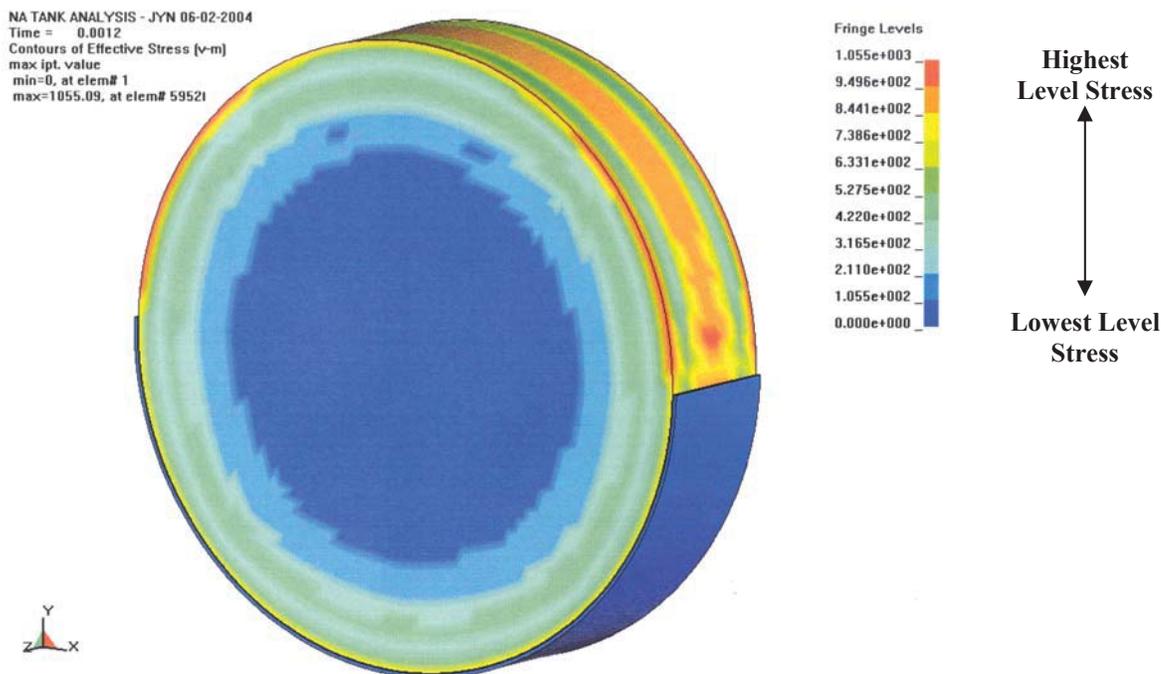
**Figure 2-4. Stress Model of the Failed Sodium Shield**

The volume change when molten sodium solidifies is 2.43% of the solid volume. Heating the sodium from room temperature to 225°F produces a total volume expansion of 4.39% (see Figure 2-3). With the shield filled with approximately one drum of sodium in excess of the capacity of the shield to hold liquid sodium, pressure was created as the solid sodium was heated and melted. The coefficient of thermal expansion of sodium metal is  $39.4 \times 10^{-6}$  in/in/°F as compared to Type 5083 aluminum alloy, which is  $13.2 \times 10^{-6}$  in/in/°F. The difference in expansion in heating sodium to its melting temperature (208°F) results in a pressure increase. The Board had a structural analysis performed which indicates that the concrete support cradle and iron supports bolted to the face of the concrete cradle restrained the aluminum shield, causing the probable failure point to be the interface between the shield and the concrete. A stress analysis representation of the restrained shield in the concrete cradle is shown in Figure 2-4 on the following page.

The unrestrained shield should have contained the sodium, although it would have bulged significantly. The void space in the top of the shield was not adequate to accommodate the

expansion of the melting sodium due to the extra drum of sodium that was added during filling.

*The Board concludes that the rupture of the sodium shield upon heating was caused by the combination of overfilling in 1971 and the stress induced by the concrete cradle.*

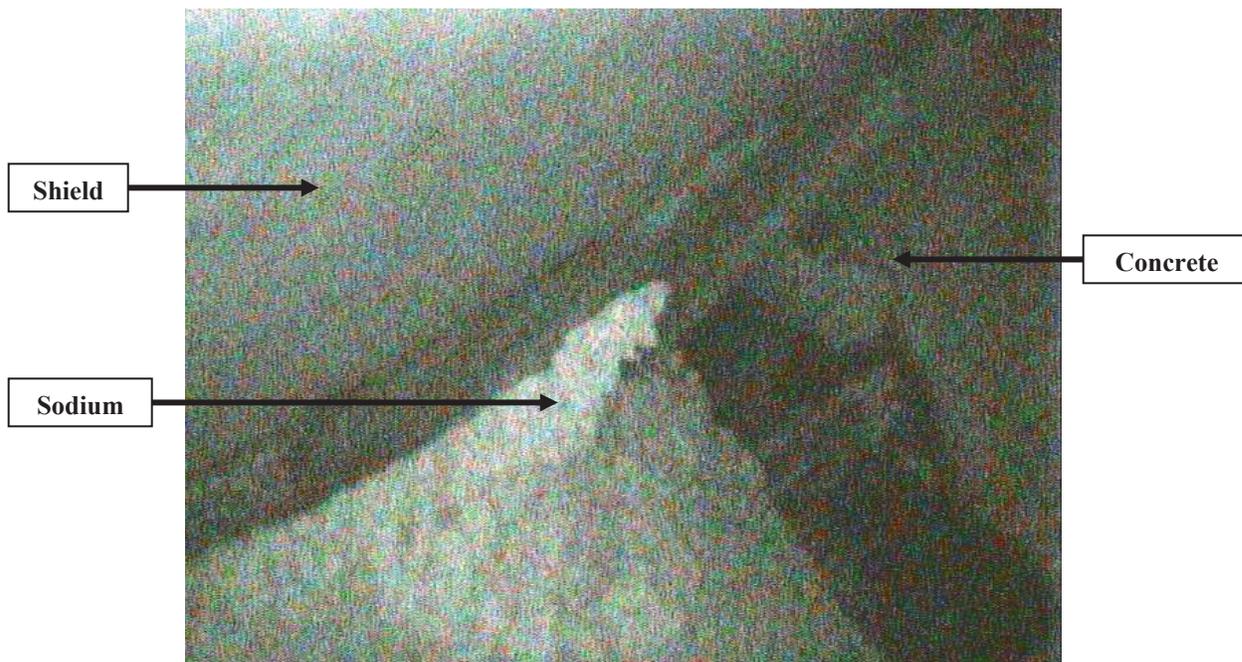
**Figure 2-5. Borescope Photograph of the Failed Shield Area**

Commodore made an initial inspection of the interior of the hot box on May 20, 2004, using a borescope inserted through an existing electrical conduit port in the side of the hot box. Seven inspections were made, with three inspections on each side parallel with the sodium shield faces and one inspection in the end opposite the door. The videotape of the inspections shows sodium on the floor of the hot box, primarily on the east side. The pattern of the flow indicates that the breach probably occurred in the 3 to 4 o'clock position of the

east side of the shield in contact with the concrete support cradle. Figure 2-5 on the following page is a borescope photograph of the probable shield failure area. The quantity of sodium that leaked from the shield was estimated to be about half of the 14,000 pounds loaded into the shield. The exact nature and location of the shield failure can only be determined after recovery has been completed and the vessel can be analyzed.

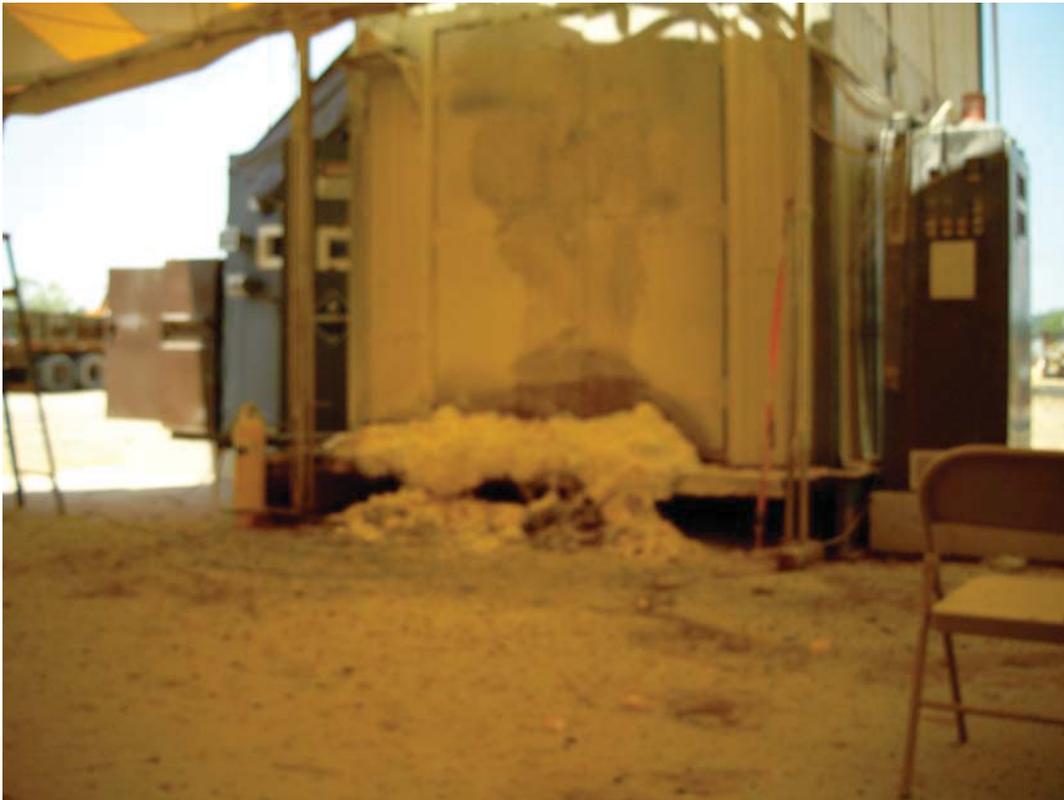
**Figure 2-6. Remnants of the Exothermic Sodium Reaction**

The accident was initiated when liquid sodium seeped under the center of the door. This occurred an estimated hour after the failure of the shield. The door gasket had contained a one-foot-deep pool of liquid sodium before failing. Power to the heaters had been turned off, and the secondary containment appeared to be working properly. Styrofoam insulation boards had been placed around the bottom exterior of the hot box to reduce the increased heat loss created after the hot box was elevated. The Styrofoam in the front of the hot box door was found to be smoldering, which was the first indication that something was amiss. A small flow of molten sodium, approximately one foot wide, flowed slowly under the door and onto the 12-inch-wide steel ledge (the scale) in front of the doors. The operators implemented emergency procedures and attempted to stop the flow of sodium by building a dam using the Class D extinguishing agent. They were aware of the potential for ignition if the sodium flowed off the ledge and onto the damp ground. There was also water on the ledge of the scale that would react with the sodium. The Commodore operators were unable to contain the flow or the subsequent exothermic reaction, so they evacuated the area, and Toxco personnel notified the PSS.

The last smoke from the exothermic reaction was noted at 2:00 am on the morning of the next day. The EOC was disbanded at 1:05 pm on May 9, 2004. During the initial recovery efforts, mineral oil was sprayed on the sodium residue, which promptly ignited and burned. The second recovery effort involved using liquid nitrogen to cool the hot box door and freeze any sodium still reacting.

*The Board concludes that the failure of the secondary containment resulted in the hot box leaking sodium. The nature of this failure cannot be ascertained until the hot box door is opened when recovery operations are resumed.*

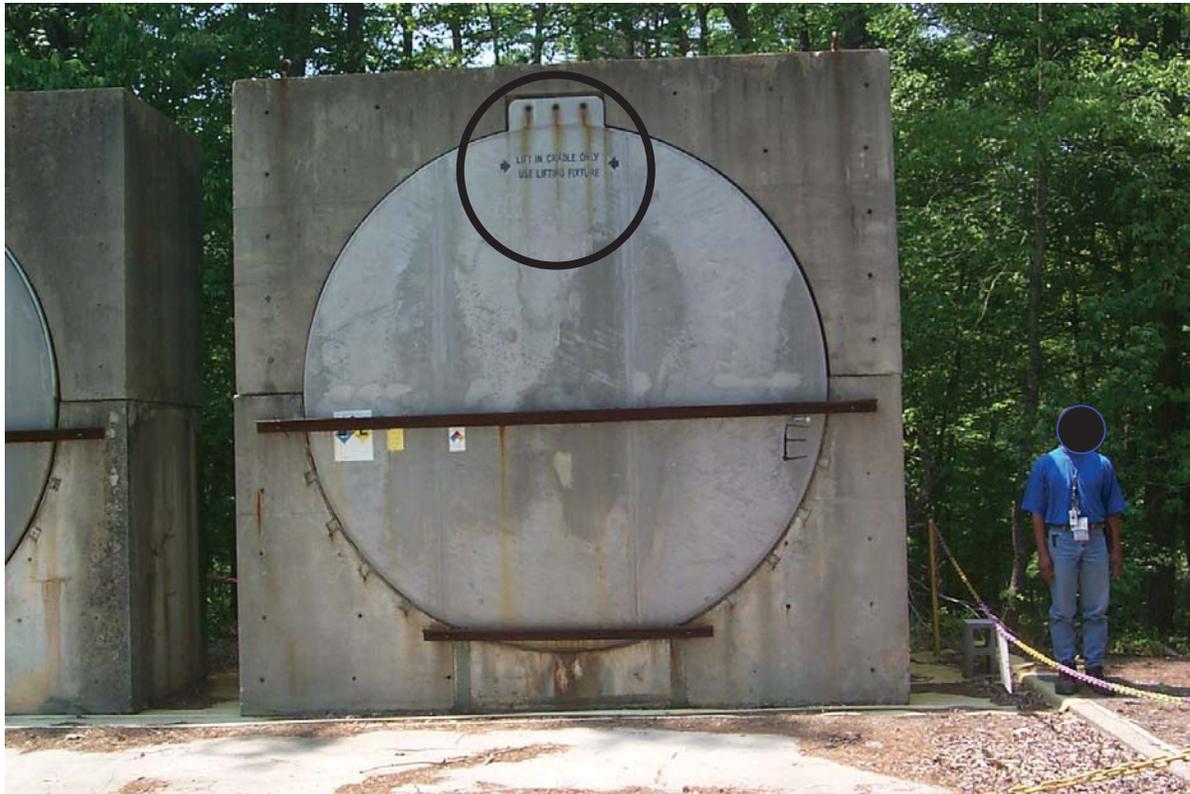
**Figure 3-1. Warning Stenciled on the Large Shields**

The failure to provide important technical information about the shields contributed to an incomplete hazard identification and analysis process. Toxco and Commodore developed procedures and systems to control the sodium hazards, and Toxco had existing radiological control procedures in place to control the shields until they could be determined to be nonradioactive through sampling and analysis. However, since the overpressurization hazard created while heating the shields was not recognized, no controls were identified to address this hazard. The hazard associated with overpressurization was further exacerbated by the presence of the concrete saddle. The large shields are stenciled with the warning “LIFT IN CRADLE ONLY---USE LIFTING FIXTURE” (see Figure 3-1).

Toxco and Commodore adhered to this warning while rigging the shields into the hot box for heating. The concrete saddle was left in the hot box under the shield during heating to stabilize the shield. Commodore and Applied Reactor Technology personnel, unaware that an overpressurization condition would exist in the shield during heating, did not recognize that the saddle would exert a restraining force on the shield as it expanded due to the expansion of the melting sodium, thus causing a stress concentration to occur. A stress analysis of the restrained shield (see Section 2.3) indicates that the concrete saddle caused stress concentrations at the aluminum/concrete interface point that likely led to the failure of the shield.
