*Type A Accident Investigation  
of the December 8, 1999*

**Multiple Injury Accident  
Resulting from the  
Sodium-Potassium Explosion  
in Building 9201-5  
at the Y-12 Plant**

February 2000

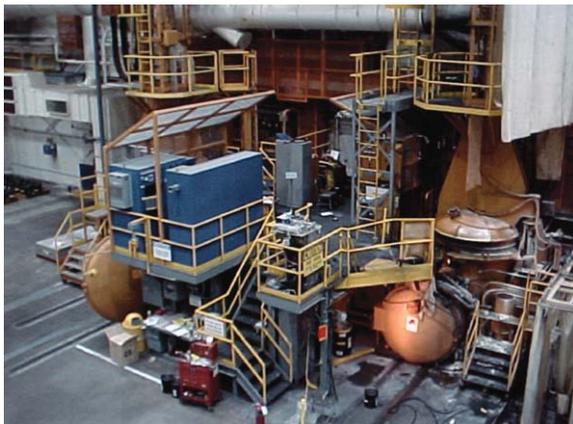
Exhibit #1. Skull Caster Furnace and Accident Scene

On December 8, 1999, ten Y-12 Plant workers were engaged in cleaning up a December 1, 1999, spill of NaK. The NaK spill occurred while workers were replacing the furnace crucible on the skull caster furnace in Building 9201-5, which uses NaK as a coolant. NaK is pyrophoric. NaK and its oxides are highly reactive and can be explosive under certain circumstances (e.g., when exposed to air it can form a potassium superoxide that is shock-sensitive and explosive when combined with hydrocarbons, such as mineral oil). On December 1, 1999, incorrect positioning of valves resulted in an inadvertent spraying of NaK into the furnace. From December 1 through December 8, the Building 9201-5 personnel planned for the removal of the spilled NaK and NaK oxides. On December 8, at about 9:30 a.m., the Y-12 Plant operators began using a steel rod and vacuum probe to remove residual NaK from the furnace (see Exhibit #1). Shortly after starting to use the steel rod, an explosion occurred in the furnace, resulting in a blast, fireball, smoke, and a shower of highly-reactive hot NaK particles. The explosion, smoke, and NaK particles caused burns and other injuries (eye injuries, ringing in ears, hearing degradation, respiratory irritation, contusions, muscle strains) in varying degrees to nine of the ten workers and one other person in the building who responded to assist after the explosion. The most seriously

injured worker received third-degree burns to about 17 percent of his body.

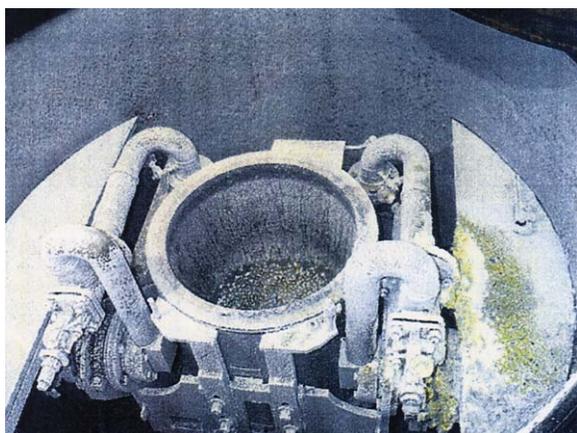
During December 2 through 7, Y-12 Plant personnel entered the area several times to observe conditions and add argon. On December 3, workers took pictures (Exhibit #2) of the furnace and observed a “fine white snow.” On this entry, the process engineer indicated that the NaK “did not look right” and that he saw things that he “hadn’t seen before.” The process engineer suspected potassium superoxide because of the yellow color observed on the surface of the NaK. He directed the furnace surface to be sprayed with mineral oil in an attempt to minimize further oxidation, which again caused reactions, noise, and generation of significant quantities of black and white smoke. On Monday, December 6, the furnace cover was lifted and the task of spraying the entire furnace with mineral oil was completed. During these recovery activities, the workers wore lab coats, booties, and gloves for PPE.

**Exhibit #2. Skull Caster Furnace and Crucible on December 3, Showing NaK and Yellow Potassium Superoxide**

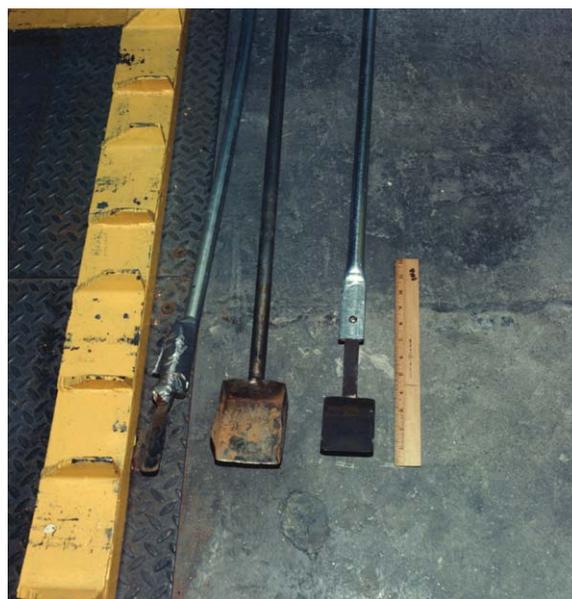
At about 9:30 a.m., the recovery team opened the cover further (about half open) and then began to use a stainless steel rod in an attempt to break up the NaK crust. The operator (CO-1) believed that this tool was too short because he had to bend over the furnace to reach the NaK with the rod. The operator then tried another lift tool (one fitted with a flat scraper on the end), but it was flimsy and could not break through the hard crust that had formed. The operator again began to use the steel rod to lift the crust in an attempt to determine whether unreacted NaK could be seen. Two of the operators then left to find materials to make a longer probe (see Exhibit #3).

**Exhibit #3. Metal Tools Used To Probe and Break Up the NaK Spill**

The explosion occurred at about 9:35 a.m., while the operator (CO-1) was using the probe to break the crusted NaK after additional mineral oil was sprayed.

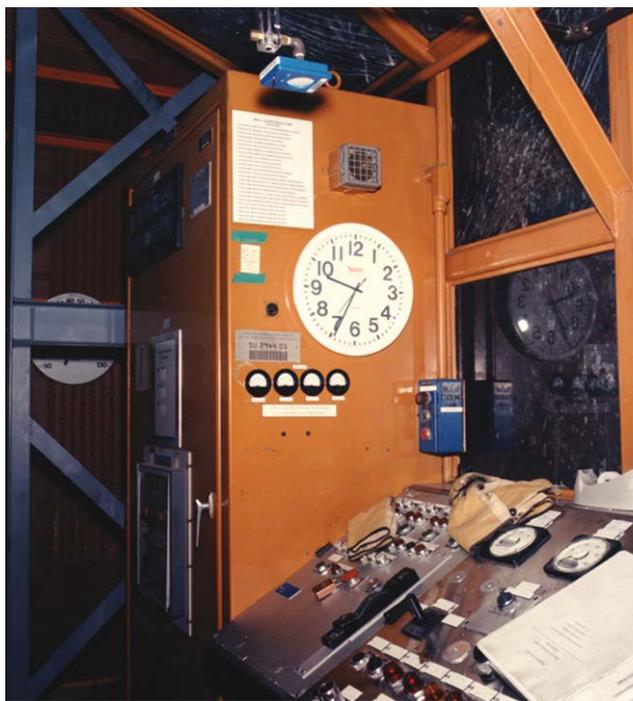
Exhibit #4. Skull Caster Furnace Control Panel Showing Clock Stopped as a Result of the Accident

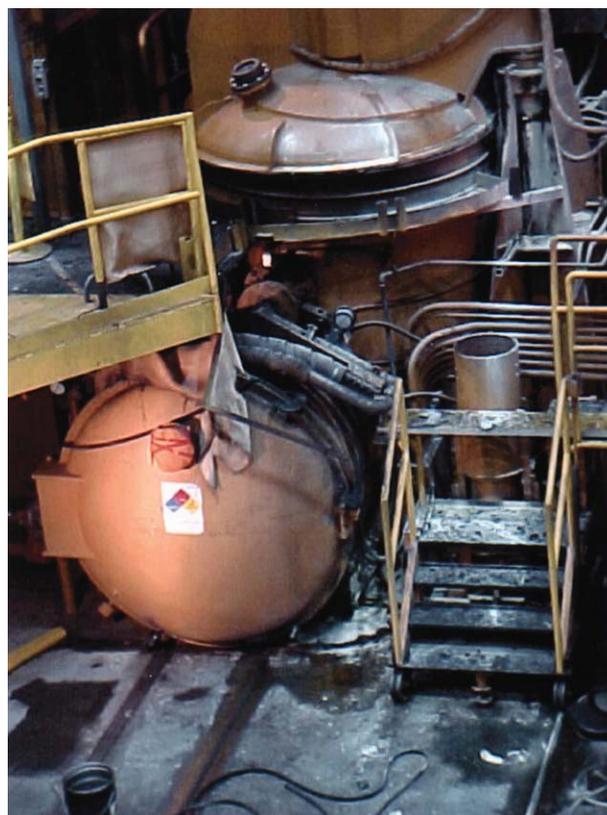
Exhibit #5. Skull Caster Furnace Showing Explosion Damage and NaK Residue

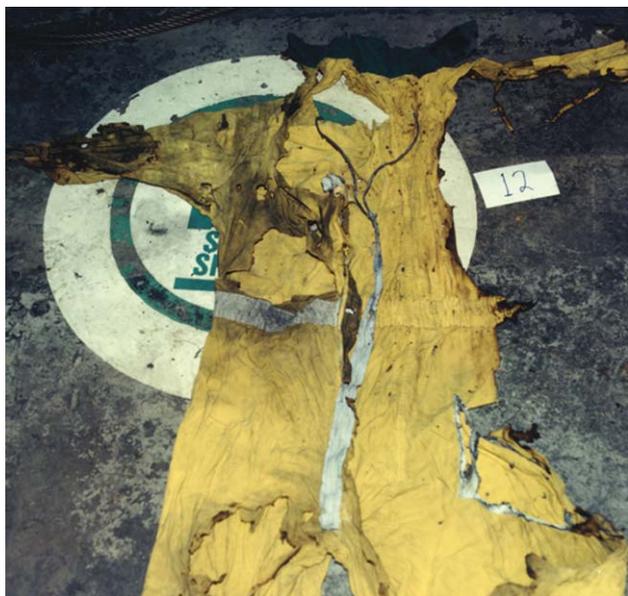
The most severely burned employee (CO-1) was leaning on a platform directly over the vessel when the explosion occurred. The force and heat of the explosion burned off most of his clothing above the waist (see Exhibit #6). He sustained burns to 25 percent of his total body surface area, including third-degree burns to about 17 percent of his body. Burns were located mainly on the upper part of the front of the body, including the head, neck, chest, fronts of the arms, and backs of the hands. He also had burns on his left torso behind his left arm, extending from the shoulder to the buttock. A small amount of NaK or its oxide was embedded in the skin of the left upper chest and was surgically removed because it was producing localized, progressive tissue destruction. The explosion also forced the worker's respirator off his face, causing a corneal abrasion of the right eye and allowing caustic burns to both eyes. The respirator minimized further burns to the face. He also sustained caustic burns to the nostrils, lips, and palate. He received skin grafts and was released from the burn center on December 21, 1999. His treatment is continuing, including additional skin grafts.

**Exhibit #6. Standard Coveralls Burned During Explosion**

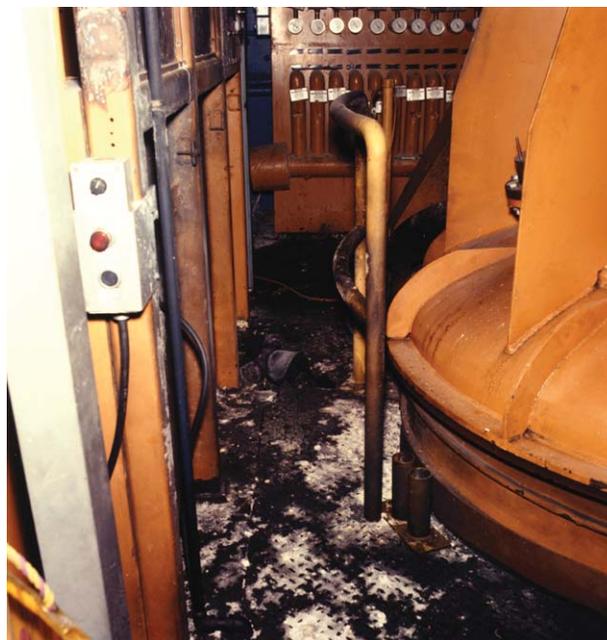
Exhibit #7. Residual NaK from Explosion Near Furnace

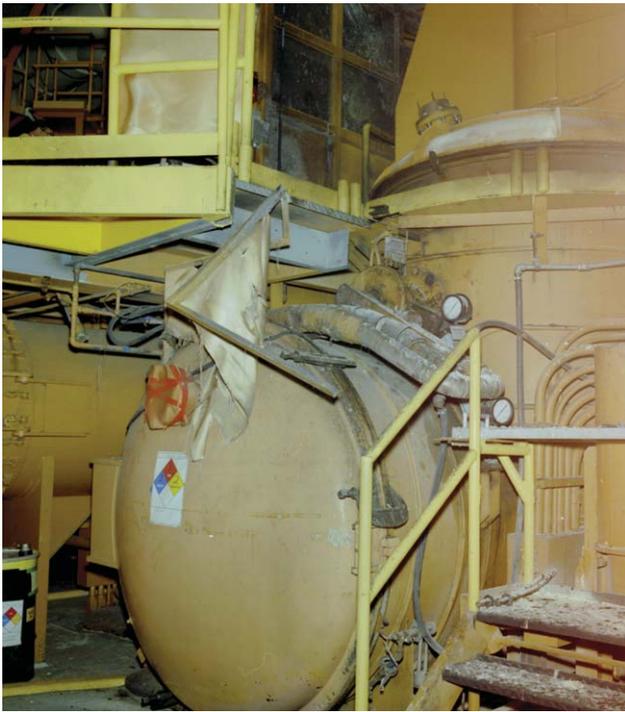
**Exhibit #8. Furnace Showing Explosion Damage**

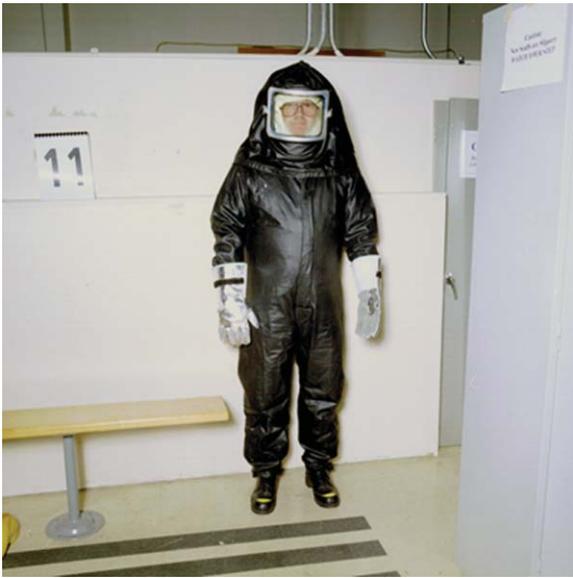
PPE for Workers Contacting NaK

- Impervious NaK suit including respiratory protection and chrome gloves
- Full protection against thermal and chemical burns
- Not worn and not staged

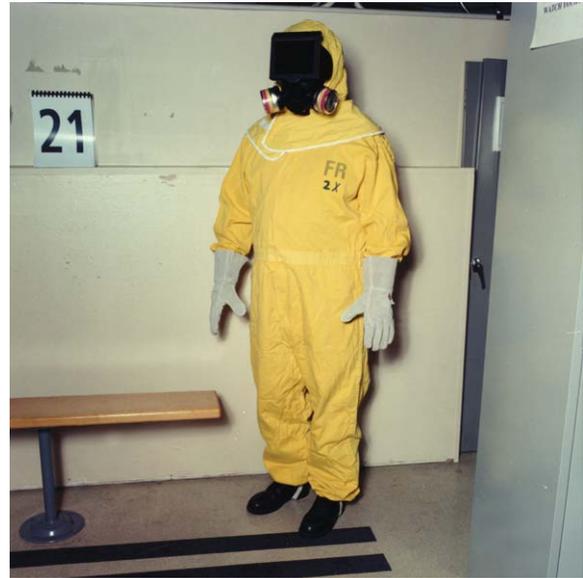
PPE for Support Personnel

- Derived from site requirements
- Includes full face respiratory protection and flame-retardant materials
- Not worn

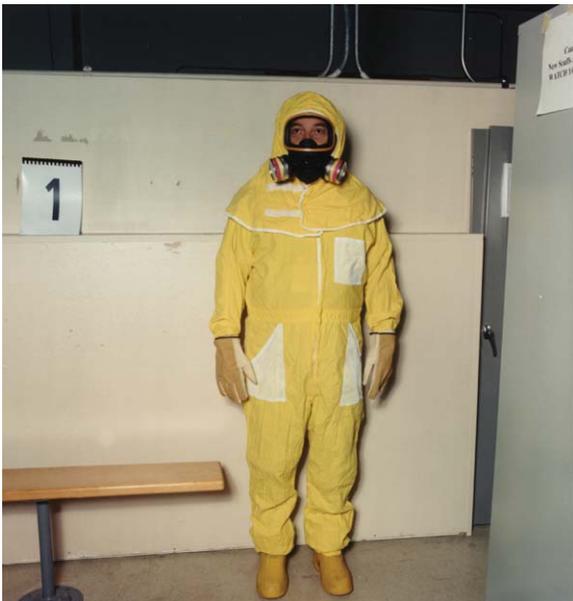
PPE Worn by Three Workers

- Standard coveralls (not flame-resistant)
- Leather gloves (not flame-resistant)
- Cartridge-type respirator (not supplied air)

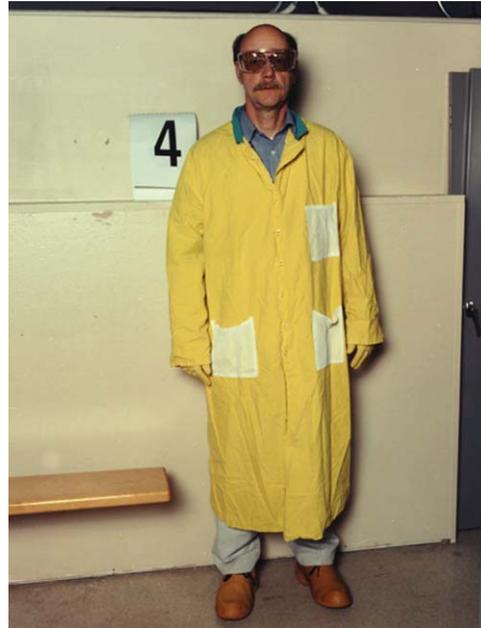
PPE Typical of That Worn by Other Workers

- Standard lab coats (not flame-resistant)
- Standard shoe covers and gloves (not flame-resistant)
- No respirator

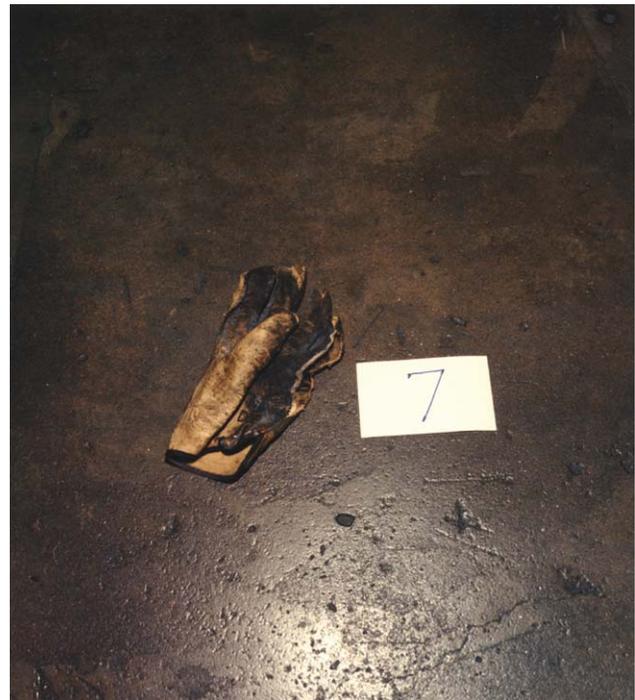
**Standard Work Glove Burned from Explosion/Fire**

Contrary to the manufacturer’s recommendations, some crucible changeout activities specified leather gloves dipped in mineral oil (not dry), and failed to specify flame retardant clothing, clothing without cuffs or pockets, or an SCBA. The 1988 final safety analysis report required PPE consisting of a “face shield, flame proof coveralls, hard hat and shoes when [operators] are working with NaK.” The current crucible changeout procedure (and recovery plan) also omitted some PPE requirements that were in older versions of the procedure. For example, earlier procedures required Nomex® (flame-retardant) coveralls for crucible removal, repair, cleaning, and installation. The Nomex® requirement was included in procedures until November 1989.

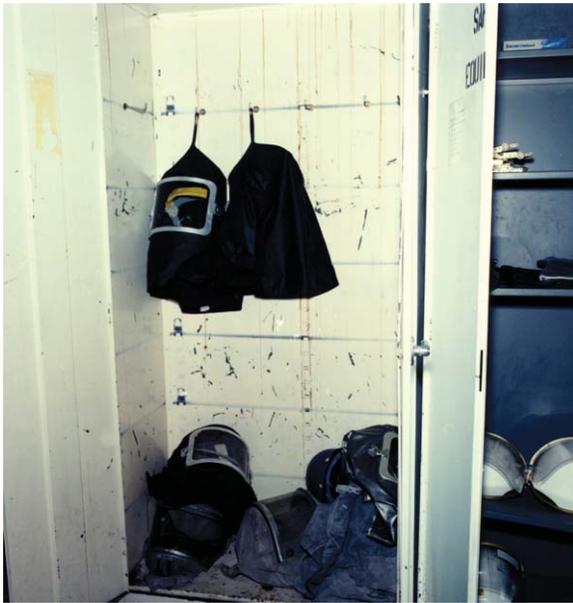
NaK suits were not staged at the furnace for the spill recovery on December 8 for either planned work evolutions or response to abnormal events (see Table 4 and Exhibit #12). Section 9 of the recovery plan requires an NaK suit for cleaning the furnace walls and floor. For abnormal response actions, Section 2 of the recovery plan refers to the abnormal response action of the crucible changeout procedure (Section 4.8), which requires the use of an NaK suit for both NaK spills and external NaK oxidation events, either of which could have occurred in removing the spilled NaK from the furnace.

**Exhibit #12. NaK Locker Showing the Lack of NaK Suits**

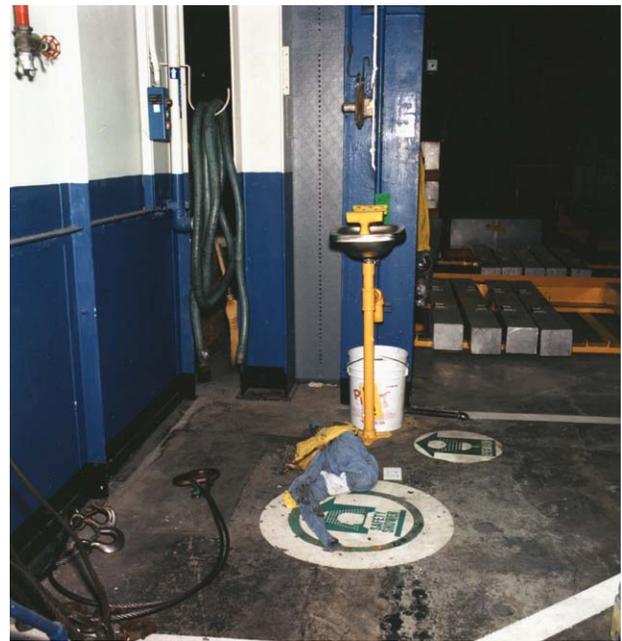
**Exhibit #13. Safety Shower Showing Lack of Berms and Burned Clothing**

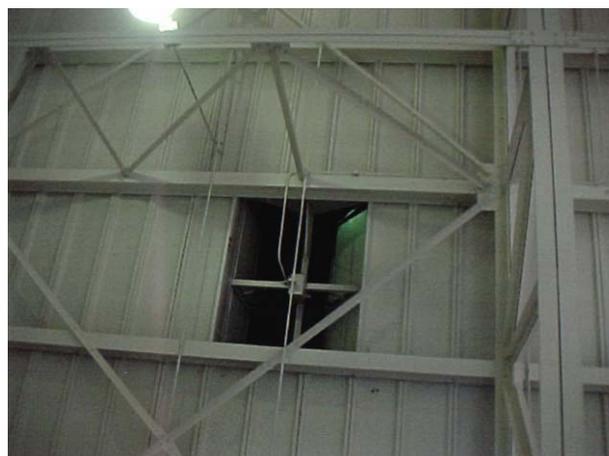
As originally designed, the high bay area above the skull caster furnace had seven smoke detectors that would cause a fire alarm and would open the roof vents to vent smoke. Modifications in the late 1960s removed these detectors from service. The accident investigation team found no justifications or fire hazards analysis for their removal. However, fire protection and engineering staff stated that they may have been removed due to nuisance alarms caused by heat and smoke from operation of the furnace. Those modifications left the high bay without adequate fire alarm protection. Additional modifications shown on

**Exhibit #14. Open Roof Vents**

design drawings connected the two roof vents over the skull melt furnace to a push button switch located in an office; however, as noted above, building personnel were unaware of the switch, and no switch was located. During a fire protection system upgrade, the other two roof vents were connected to smoke detectors for a large industrial saw and an oven in the general area, but away from the skull caster furnace. During testing of the new system before the spill and accident, the roof vents did not function, so they were presumably electrically inoperable at the time of the spill and accident. A work request was initiated to correct the deficiency, but the work had not been completed before the NaK spill and accident.
