NUREG-0050

RECOMMENDATIONS RELATED  
TO  
BROWNS FERRY FIRE

Report By Special Review Group

**Date Published: February 1976**

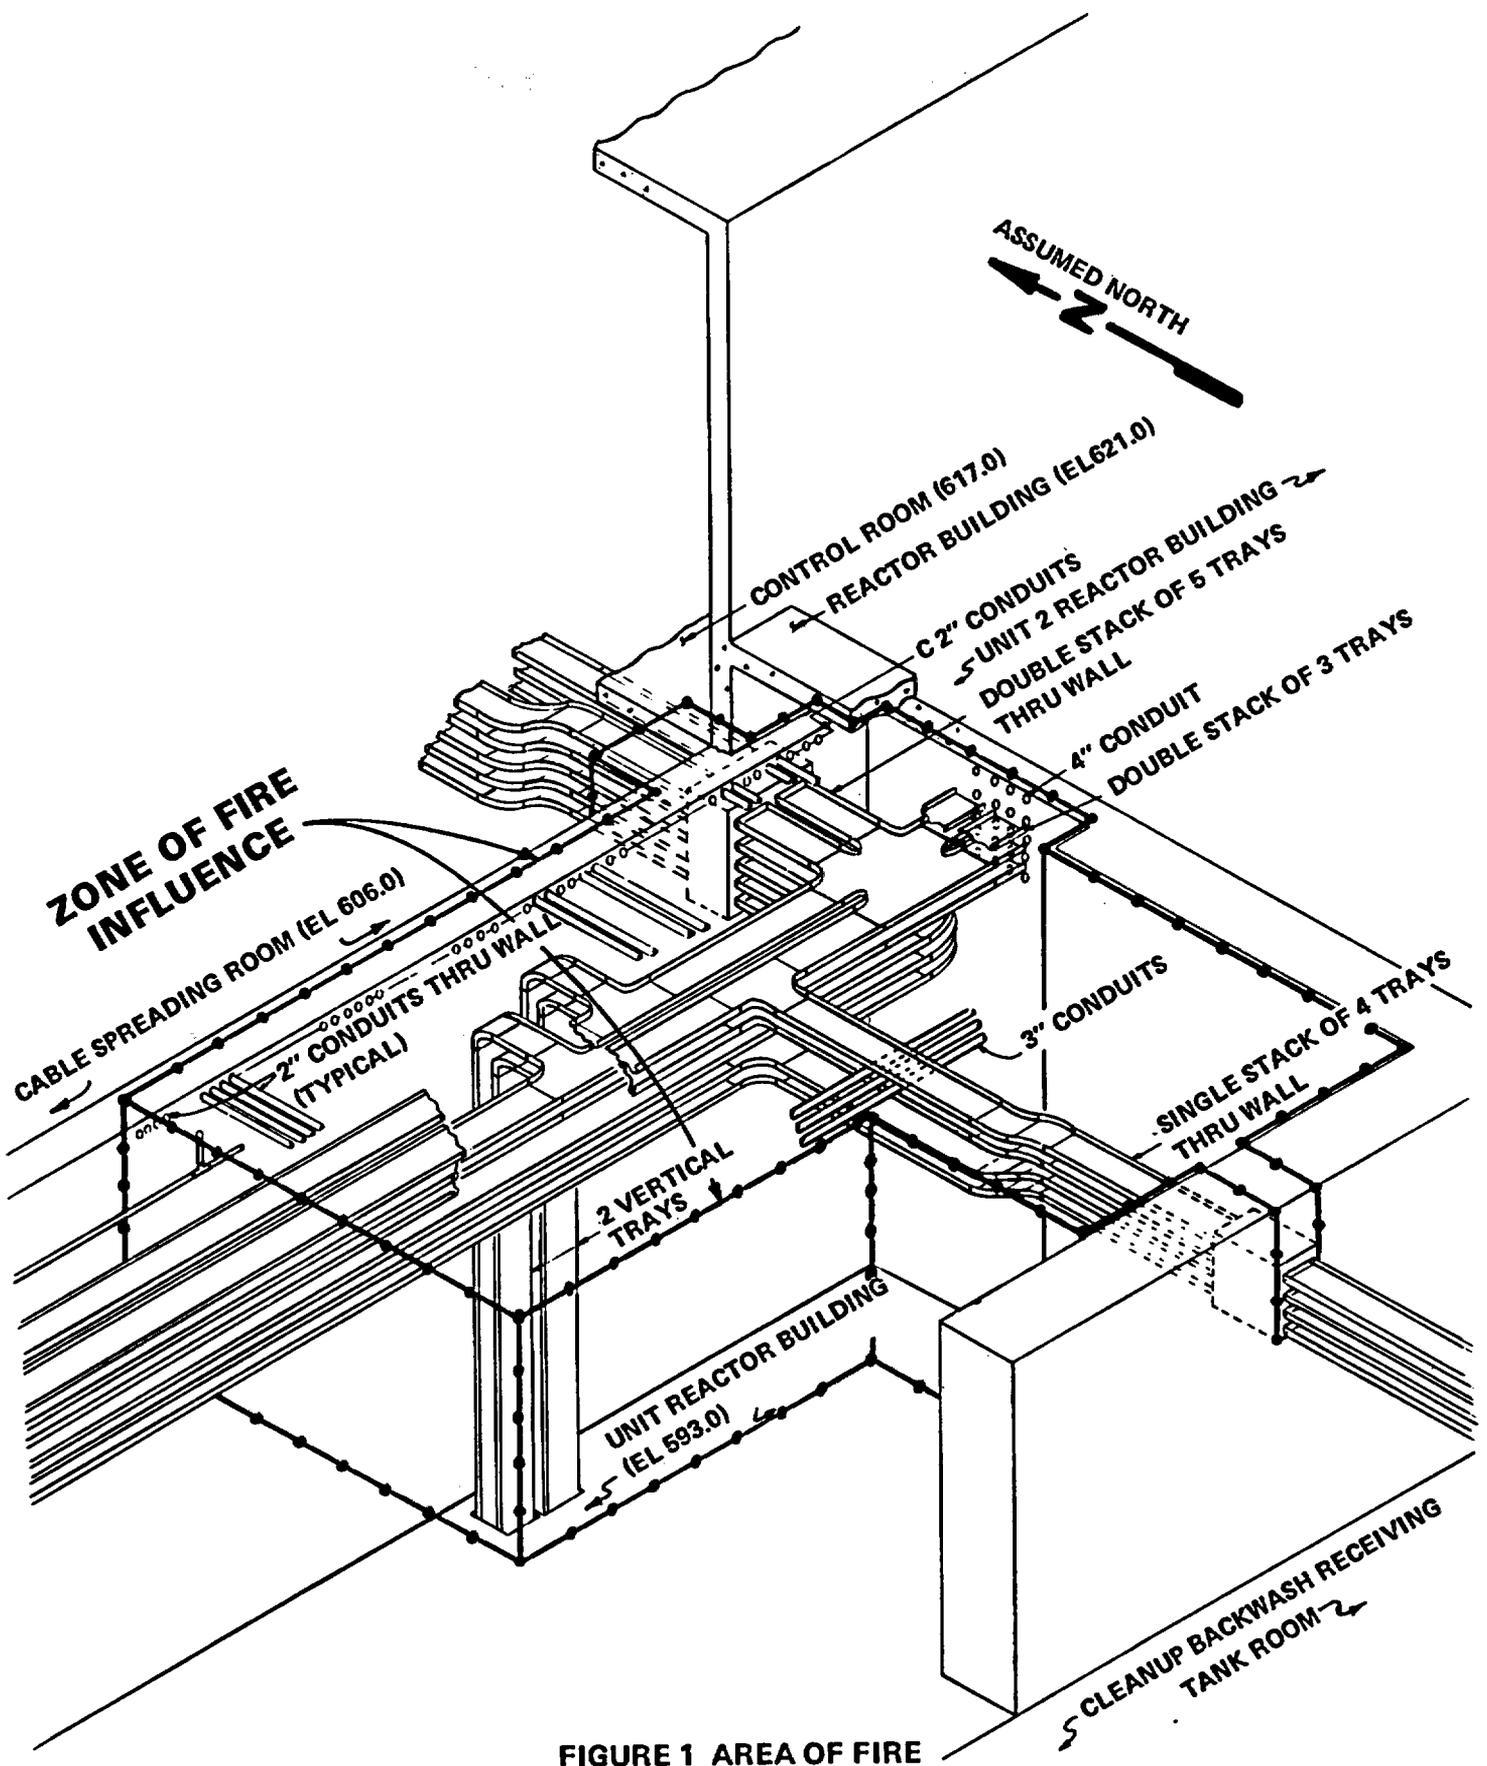
**FIGURE 1 AREA OF FIRE**

The fire originated in a cable tray penetration between the cable spreading room and the reactor building. Figure 1 shows the extent of the fire damage. Cables and raceways were damaged for a distance of about five feet inside the spreading room. The major damage occurred on the reactor building side of the penetration. Visible damage was observed in the cables in a double stack of three trays south as far as a fire stop about 28 feet from the penetration and west along the double stack of five trays for a distance of about 38 feet. Cables in four vertical trays were also damaged downwards for a distance of about 10 feet.

Trays and Conduits. Damage to trays and conduits includes some corrosion caused by the corrosive atmosphere created by the burnt cable jackets and insulation. Some aluminum conduit located above the burning trays was melted by the intense heat, and some cracking was noted in some of the steel conduits.

Damage to Piping Systems. The only direct damage of pipe was the melting of a soldered joint in an air supply line which passed through the fire area. This air line supplied control air to valves in the Unit 1 Reactor Water Cleanup Demineralizer System, and the line from the refueling floor to the Standby Gas Treatment System.

Structural Damage. There is no evidence of significant structural damage except to trays, tray supports, conduits, conduit supports, and perhaps some piping supports in the fire area.

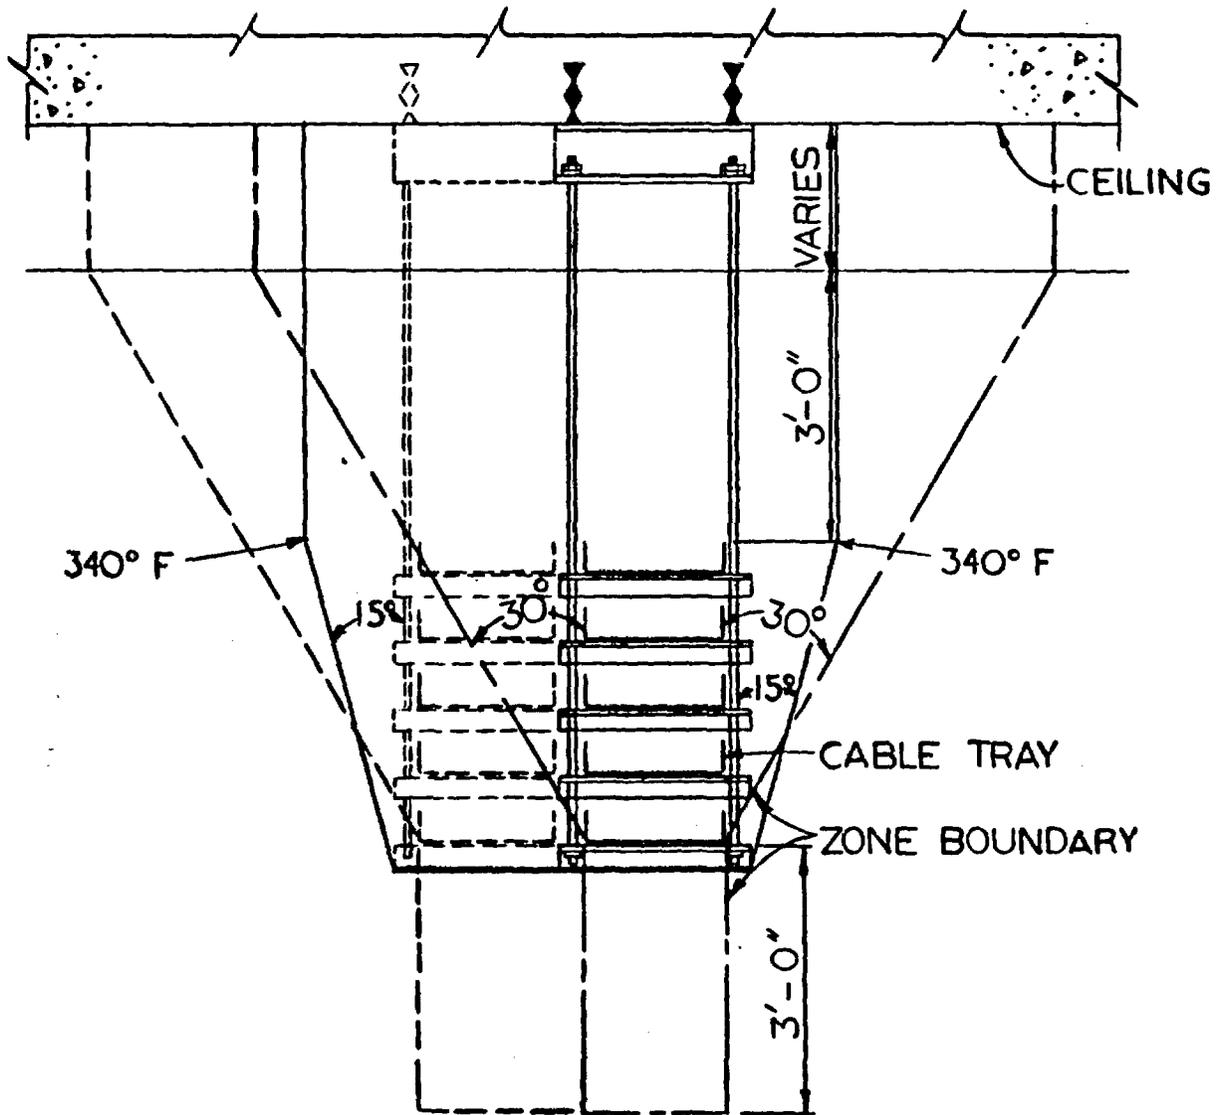
FIGURE 2 REGION OF INFLUENCE OF FIRE IN CABLE TRAY

The Review Group has concluded that the existing NRC separation and isolation criteria require improvement. The Browns Ferry fire has shown a number of areas in which improvement is needed

These include the assumptions underlying isolation criteria, the ways in which the requirements are stated, inclusion of conduit, and the role of fire barriers and fire retardant coatings.
