U.S. CHEMICAL SAFETY AND HAZARD INVESTIGATION BOARD

# INVESTIGATION REPORT

## COMBUSTIBLE DUST FIRE AND EXPLOSIONS

**CTA ACOUSTICS, INC.**

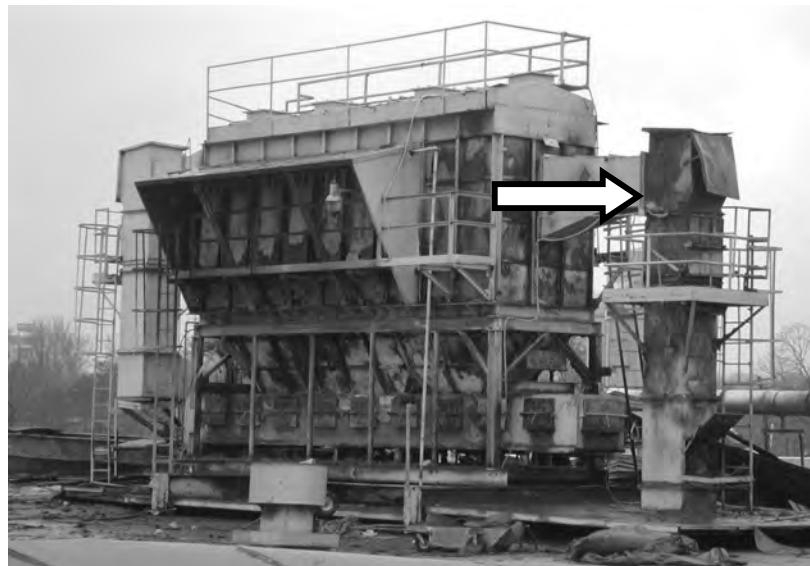
Figure 4. Fire damage to inlet duct of line 405 baghouse.

Two operators on the roof stated that moments after the baghouse was turned back on at 7:30 am, flames shot up through the inlet ducts, into and out of the baghouse (Figure 4). Both operators were burned—one received minor facial burns; the other received second-degree burns to his hands and face, which required a lengthy hospital stay. Inside the plant, personnel located about 80 feet northwest of line 405 observed smoke coming from the line prior to the initial explosion. Once the explosion occurred, personnel both heard it, and saw a fireball emerge from the south end of the oven.

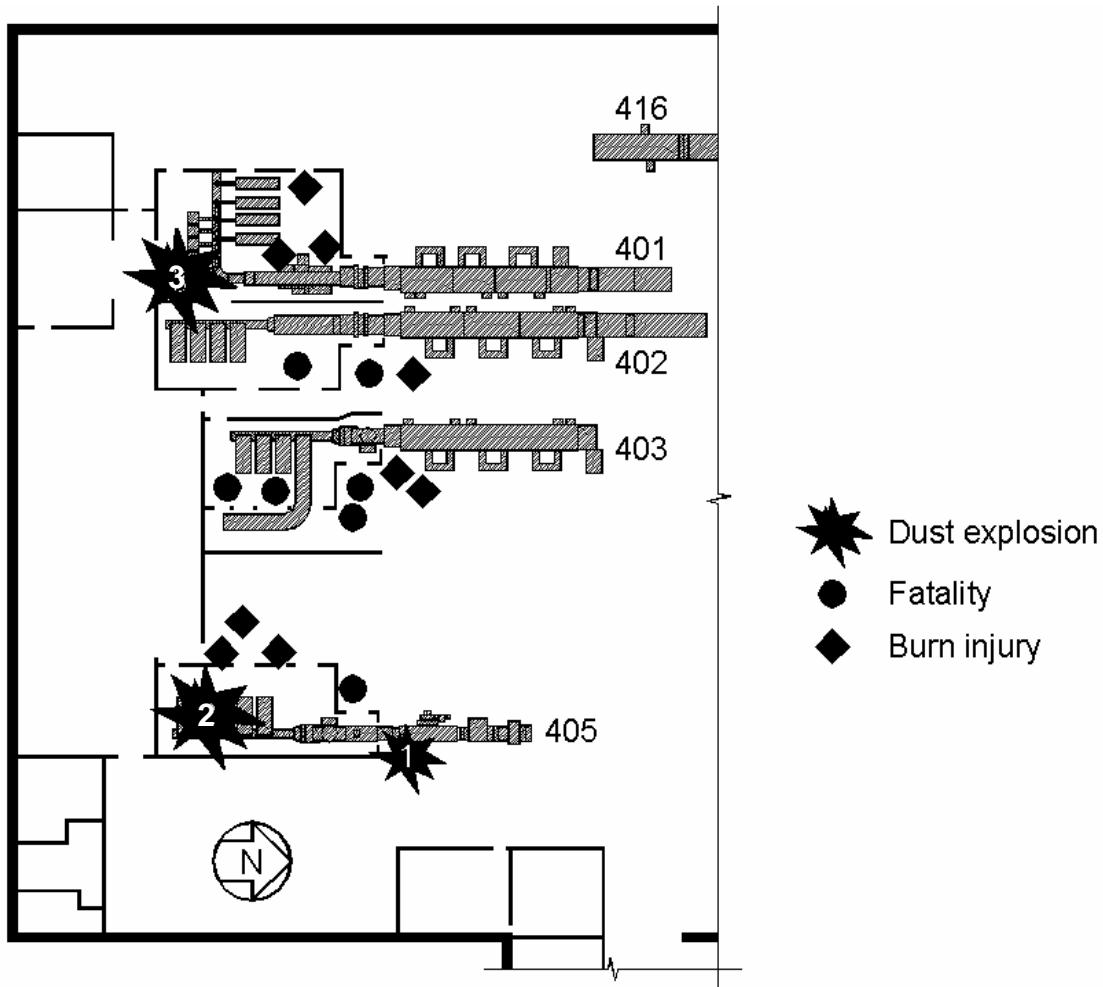
Figure 5. Sequence of dust explosions and likely locations  
of those killed and burned in the production area  
(Note: All employee injuries not shown in figure).

Figure 5 depicts the sequence of explosions and shows the likely locations of those who were burned in the production area. See Section 5.4 for a description of the extent of injuries to employees.

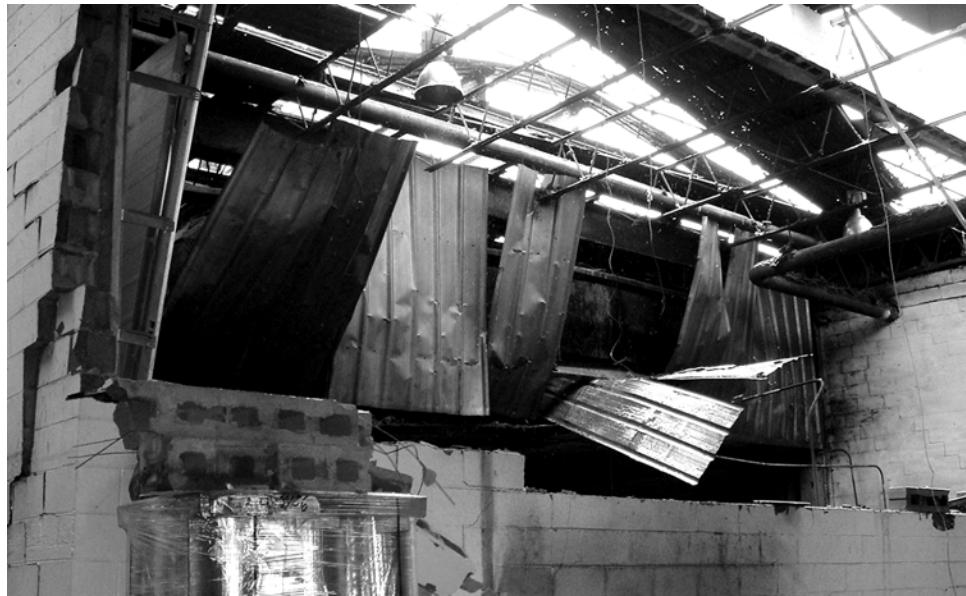
Figure 6. Collapsed firewall and metal panels at south end of line 405 blend room.

The fireball generated by the initial explosion near the line 405 oven ignited dispersed combustible dust, which caused a secondary explosion in the relatively confined area above the line 405 blend room. The force of this explosion damaged the firewalls to the east and south and pushed metal wall panels above the blend room roof on the south side out to the south (Figure 6). The explosion also pushed ceiling

panels and lights down inside the blend room. The pressure wave vented out of the building, damaging metal wall panels on both the south and east outer walls.

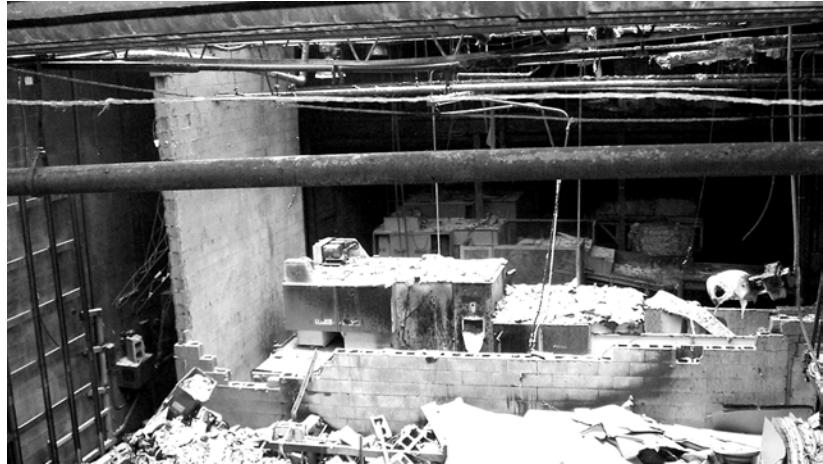
Figure 7. Collapsed firewall between lines 403 and 405.

- A collapsed firewall between lines 403 and 405 (Figure 7).
- Metal wall panels above the line 403 blend room on the east side that were blown to the west.
- Burnt residue on the building's roof trusses.

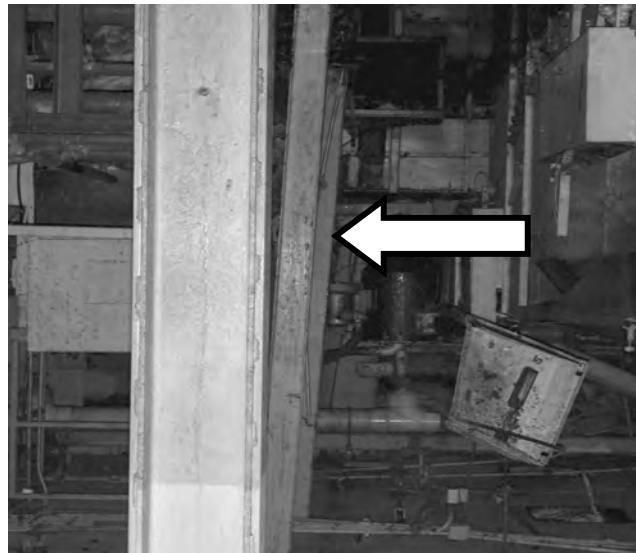
Figure 8. Bent support column in line 401 blend room.

The fireball continued to move west over the top of the line 402 blend room and into line 401. CSB investigators noted extensive explosion damage at line 401, nearly 300 feet from the initial explosion's point of origin at line 405. Physical evidence revealed that an additional secondary dust explosion

occurred in the southeast corner of the line 401 blend room, another confined area. The firewall south of line 401 was partially collapsed, and concrete blocks dislodged from this wall fell to the south. The force of the dust explosion pressure wave likely bent a steel column on the west side of the blend room (Figure 8). Metal panels of the north and west walls were deformed outward. A large hole was blown in the building roof above the southeast corner of the blend room.

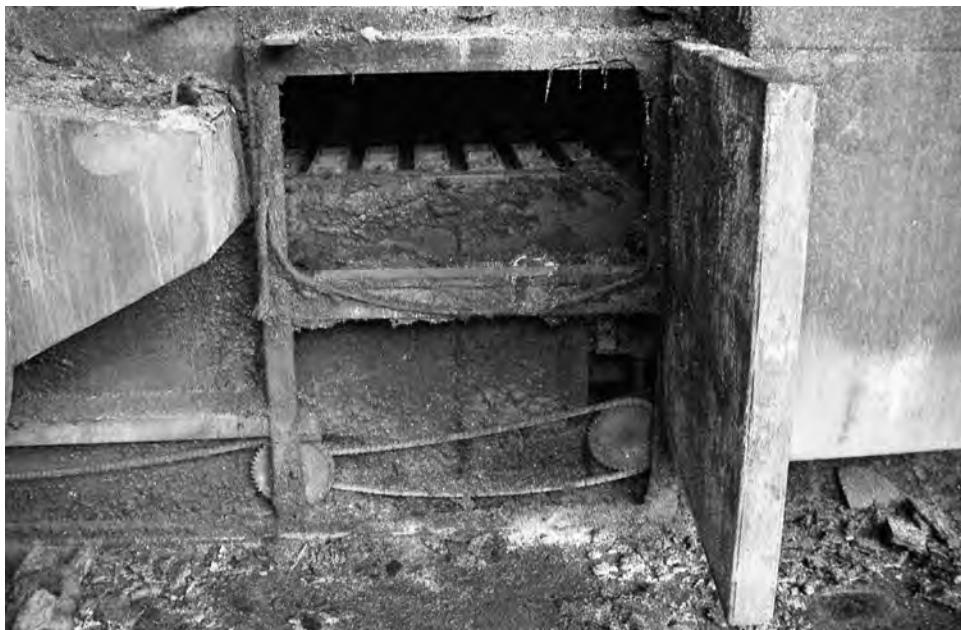
Figure 13. Interior of line 405 oven.

CSB also examined the interior of the oven; virtually all the combustible material that likely had been inside was burned away (Figure 13). In contrast, the interior of the ovens on lines 401, 402, and 403 contained accumulations of resin powder/fiberglass debris. The chain-driven oven flights for 405 were

burned clean but otherwise intact and undamaged. Metal discoloration was noted on the interior of the line 405 oven; however, CSB found no evidence of explosion damage inside the oven.

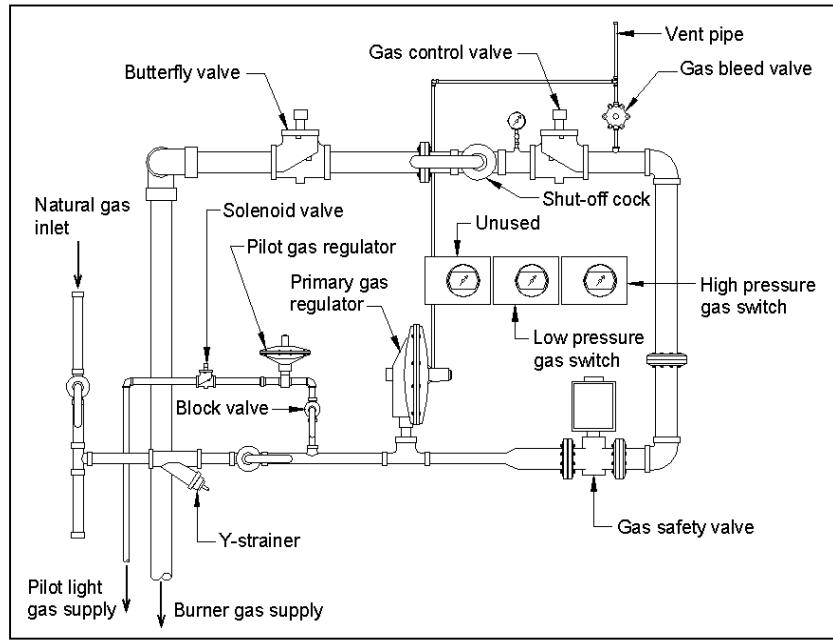
Figure C-1. Oven natural gas piping manifold.

No significant external gas leaks into the building were found. All internal gas leaks (i.e., gas control valve, gas bleed valve) would have been directed to the externally piped gas vent line.

CSB reviewed these findings and conclusions and determined that equipment testing results identified no single component failure as the cause of the incident.
