U.S. Chemical Safety and Hazard Investigation Board

Hoeganaes Corporation: Gallatin, TN Metal Dust Flash Fires and Hydrogen Explosion

January 31, 2011; March 29, 2011; May 27, 2011

No. 2011-4-I-TN

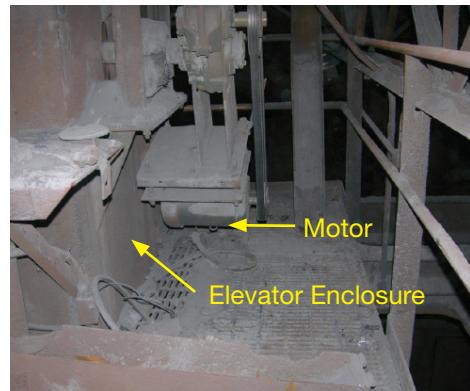
**FIGURE 4 (RIGHT)**

Scene of January 31, 2011, incident area.

Based on their observations, they did not believe that the belt was off-track and requested, via radio, that the operator in the control room restart the motor (Figure 4). When the elevator was restarted, vibrations from the equipment dispersed fine iron dust into the air. During a CSB interview, one of the workers recalled being engulfed in flames, almost immediately after the motor was restarted.

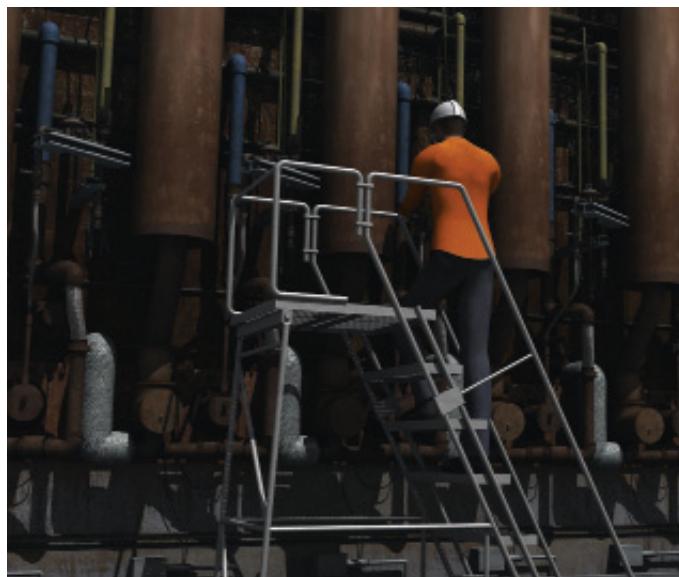
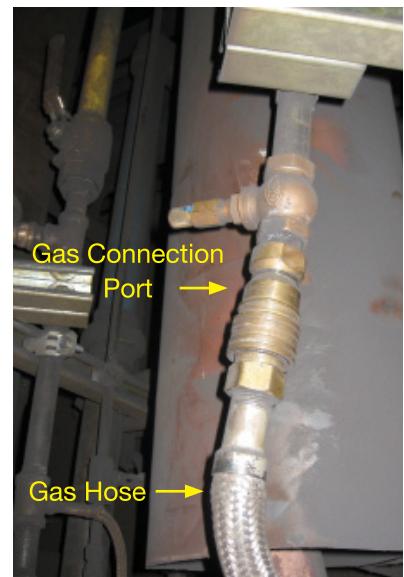
FIGURE 7 (RIGHT)

The gas line connection involved in March 29, 2011, incident.

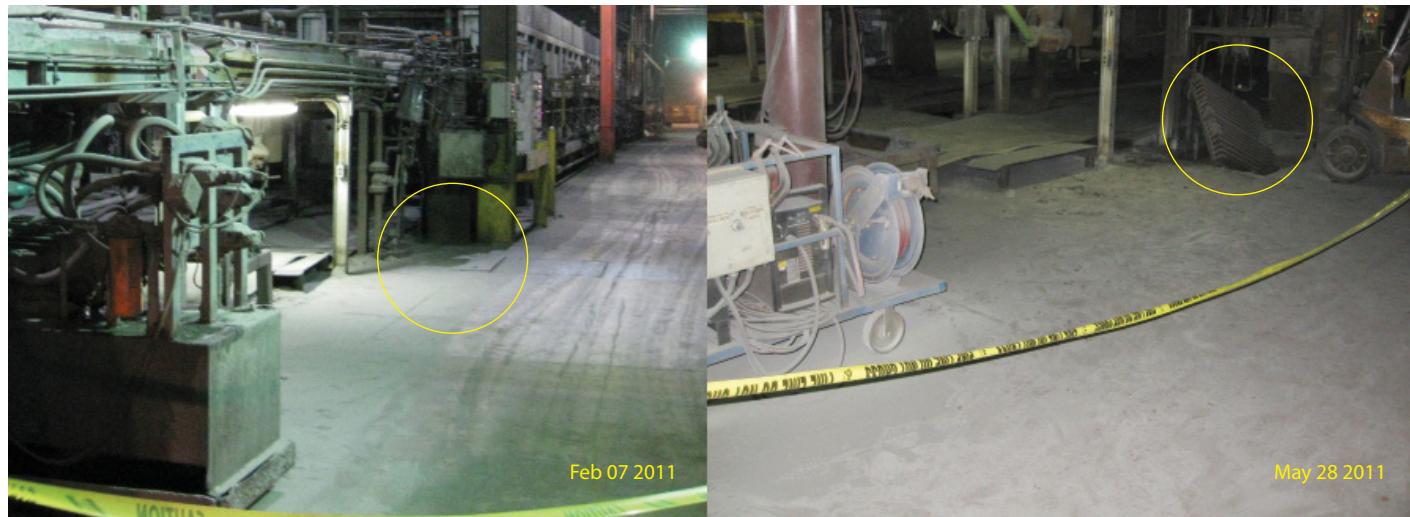
**FIGURE 9 (TOP)**

Scene of the May 27 incident before (left, taken during the CSB's January 31 incident investigation) and after (right). Note visible accumulations of iron powder on surfaces. Circled areas show trench cover location.

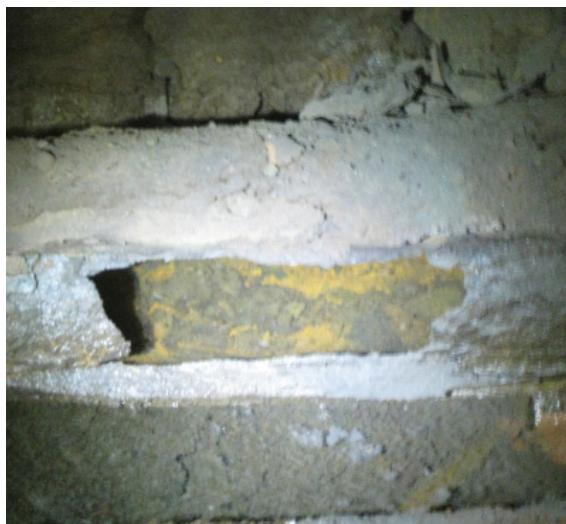
FIGURE 11 (TOP LEFT)

Interviews with eyewitnesses indicate that just as the first trench cover was wrenched from its position by the forklift, friction created sparks, followed by a powerful explosion. Several days after the explosion, CSB investigators observed a large hole (approximately 3 x 7 inches) in a corroded section of piping that carried hydrogen and ran through the trench (Figure 11).

Hole in 4-inch piping after the May 27, 2011, incident.

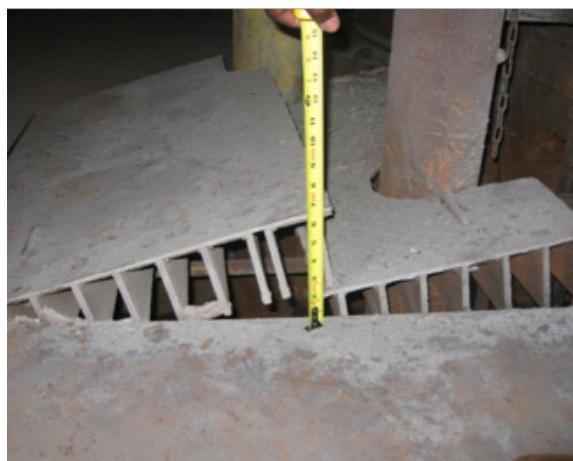
Upward disturbance of trench covers caused by the hydrogen explosion in the May 27, 2011, incident.

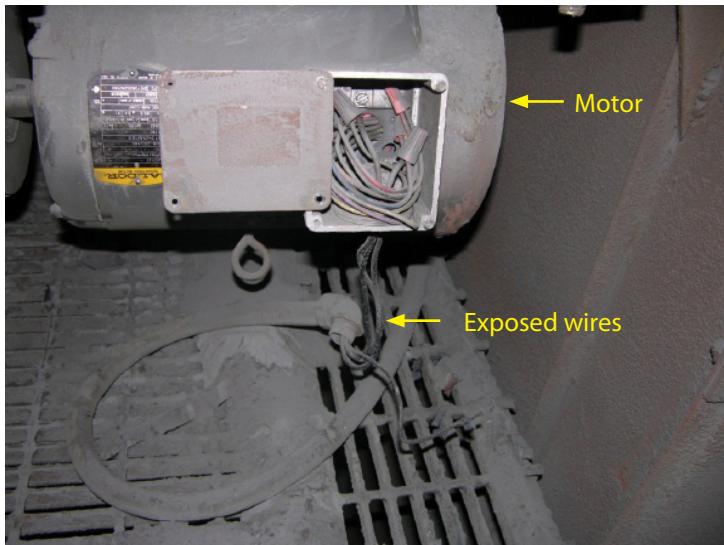
FIGURE 15

Exposed electrical wiring on elevator motor near January 2011 incident site (motor panel cover was rotated post incident by fire department).

The testing contracted by Hoeganaes in 2010 determined that the minimum ignition energy for representative iron dust samples was greater than 500 mJ, and that a continuous arc would ignite the samples. One witness at ground level reported hearing an “electric sound” at the time of the incident. The motor operating bucket elevator #12 was a likely source of ignition since it had exposed wiring, was not properly grounded, and was within a few feet of the dust cloud source. The wiring was exposed because the electrical conduit supplying power to this motor was not securely connected to the motor’s junction box.

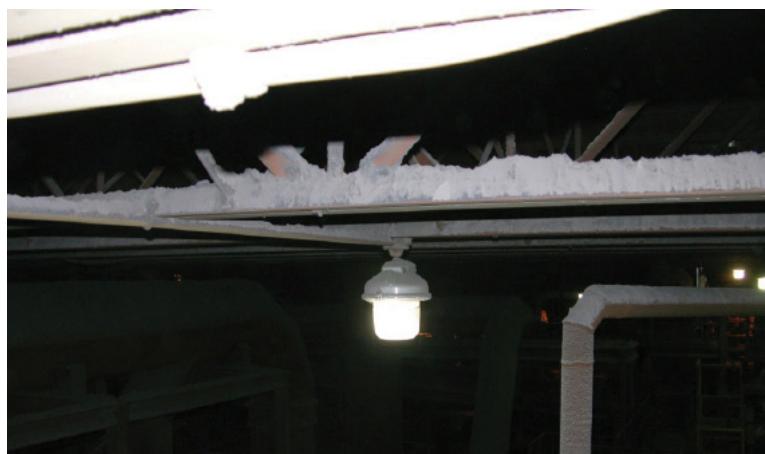
FIGURE 16

Mounds of iron dust along elevated surfaces at the Gallatin plant, February 3, 2011.

The Building Construction section of the code states, “Avoid beams, ledges or other places where dust may settle, particularly overhead.” The Gallatin facility, built in the 1980s, was not designed to avoid significant overhead accumulations of dust. The code calls for designing and maintaining dust-tight equipment to avoid leaks and, where this is not possible, to enforce good housekeeping procedures.

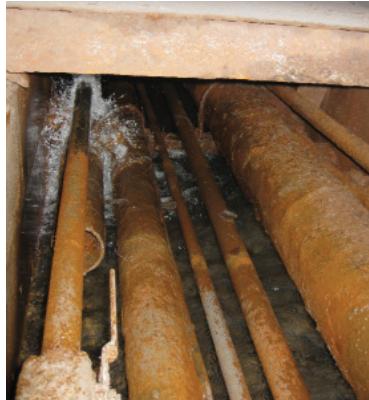
FIGURE 17

Water flow (upper left of photo) and externally corroded pipes in the trench involved in the May 27, 2011, incident.

According to ASME B31.3, design concerns about ambient conditions around process pipes focus on environments and changes that can create physical stresses in the piping. Section 10.5.3 of NFPA 55 requires annual maintenance including inspection for physical damage and leak tightness. CGA G-5.4 similarly requires regular inspection for physical damage and leak tightness. However, Hoeganaes did not regularly inspect the pipes in the trench. The design and maintenance of this trench, should have addressed the issue of slow corrosion over time caused by the hot water runoff and solids accumulation.

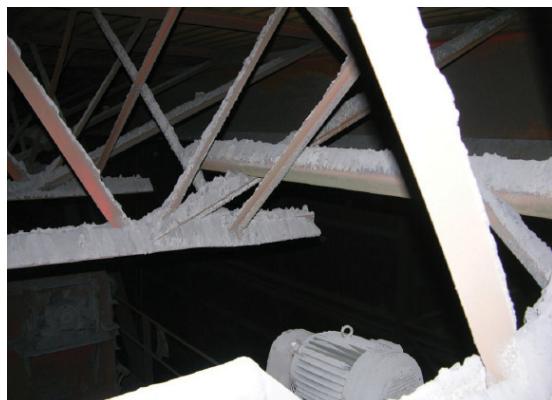
FIGURE 18 (LEFT)

Observations by CSB investigators at the Gallatin facility shortly after the first incident indicated that combustible dust was leaking from equipment and that housekeeping was ineffective (see Figures 16, 18, 19, 20 and 21). Combustible iron dust coated almost every

Iron dust on rafters,
February 3, 2011.

surface up to 4 inches deep and was visible in the air. Mitigation of the combustible dust hazard by Hoeganaes was limited to a less-than-adequate vacuuming service, sparsely enclosed conveyance equipment, and an inadequate baghouse filtration system.

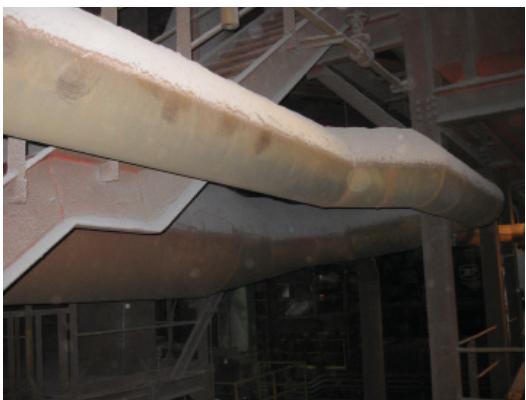
**FIGURE 19 (RIGHT)**

Iron dust on overhead
surfaces, February 3, 2011.

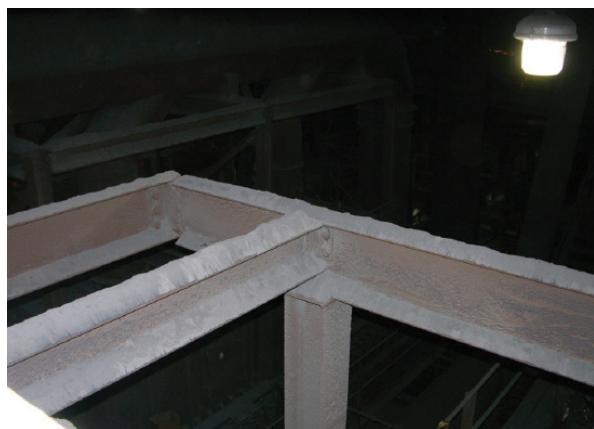
FIGURE 20

Iron dust on structural
supports, February 3, 2011.

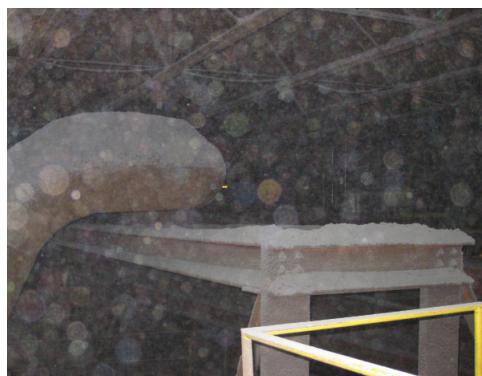
FIGURE 21

Photo of equipment obscured by airborne dust, taken by CSB investigators, February 7, 2011.
