U.S. CHEMICAL SAFETY AND HAZARD INVESTIGATION BOARD

ALUMINUM DUST EXPLOSION

HAYES LEMMERZ INTERNATIONAL—HUNTINGTON, INC.

REPORT NO. 2004-01-I-IN

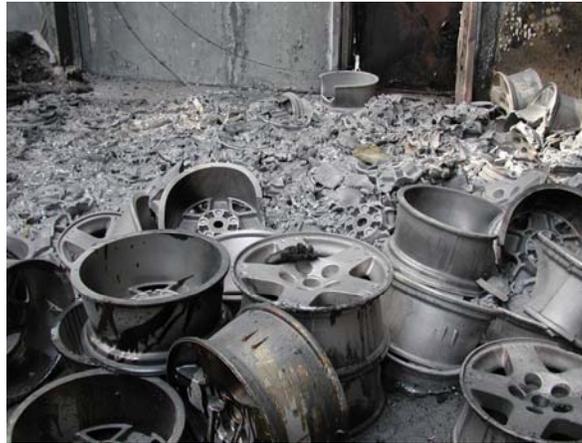
The fireball ignited roofing material and insulation, along with a small accumulation of combustible material stored behind the kiln dryer control panel. North-west of the furnace sidewall, plastic pallets containing rejected aluminum wheels waiting to be re-melted were also ignited, and some of those wheels eventually melted (Figure 14).

Figure 14. Melted wheels near furnace 5 after the fire.

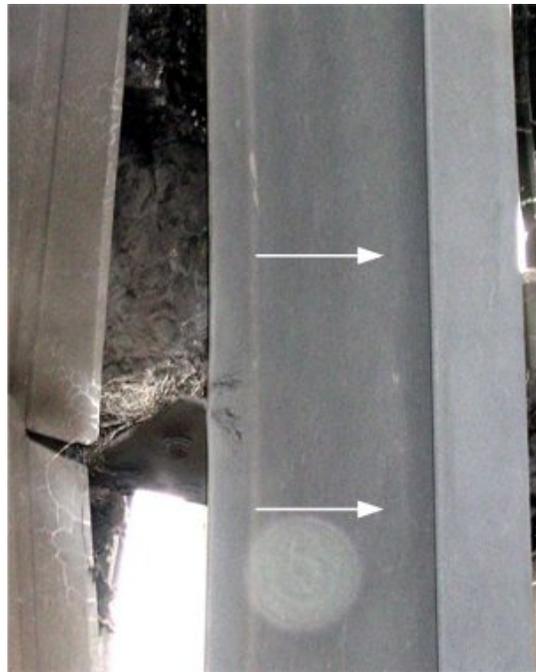
Figure 25 Beam slightly deflected by drop box impact. Arrows on either side of the point of impact show the direction of bending

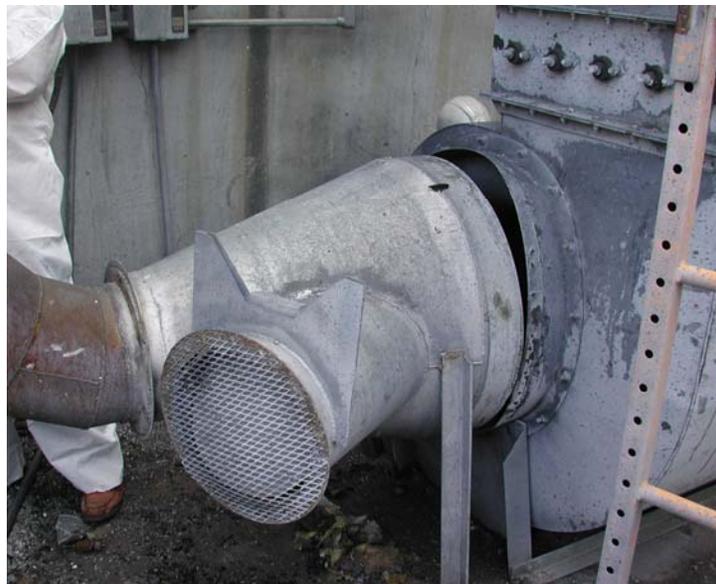
Figure 27. Fume hood exhaust fan cover damaged by overpressure.
