# **Type B Accident Investigation Board Report**

**May 8, 2004, Exothermic Metal Reaction Event  
During Sodium Transfer Activities  
East Tennessee Technology Park  
Oak Ridge, Tennessee**

**June 2004**

**Oak Ridge Operations Office  
U.S. Department of Energy**

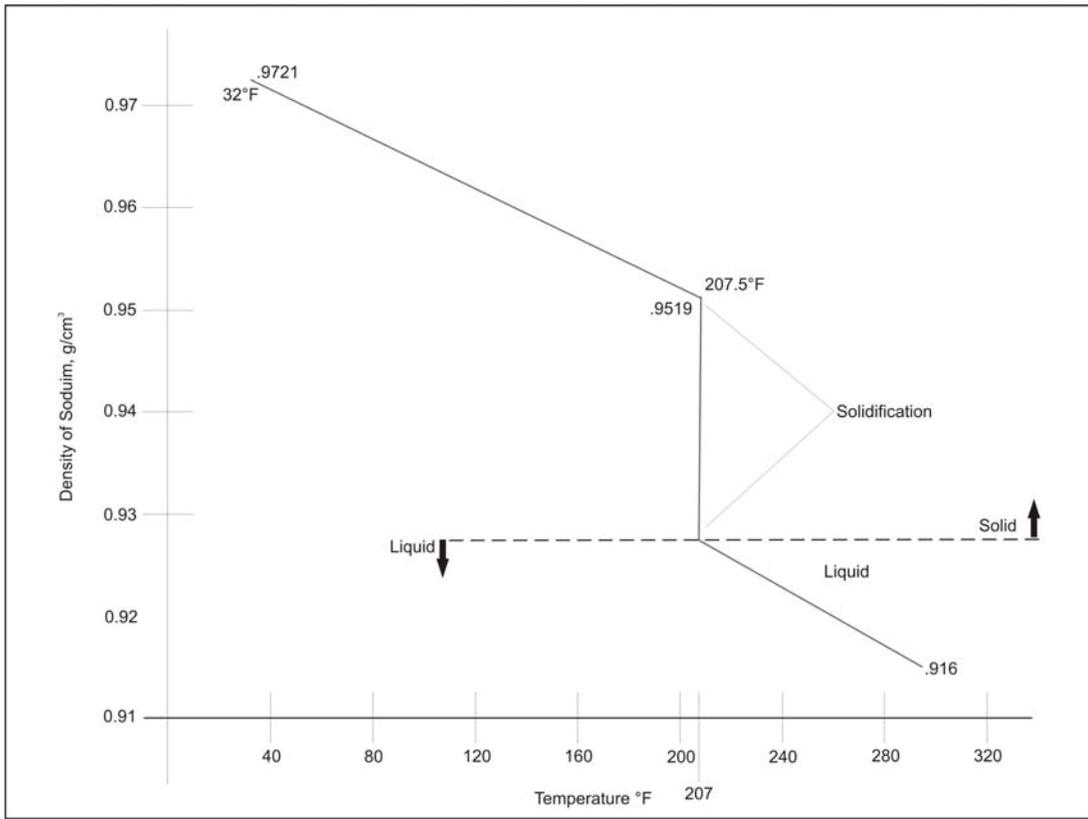
**Figure 2-3. Sodium Density as a Function of Temperature**

The volume change when molten sodium solidifies is 2.43% of the solid volume. Heating the sodium from room temperature to 225°F produces a total volume expansion of 4.39% (see Figure 2-3). With the shield filled with approximately one drum of sodium in excess of the capacity of the shield to hold liquid sodium, pressure was created as the solid sodium was heated and melted. The coefficient of thermal expansion of sodium metal is  $39.4 \times 10^{-6}$  in/in/°F as compared to Type 5083 aluminum alloy, which is  $13.2 \times 10^{-6}$  in/in/°F. The difference in expansion in heating sodium to its melting temperature (208°F) results in a pressure increase. The Board had a structural analysis performed which indicates that the concrete support cradle and iron supports bolted to the face of the concrete cradle restrained the aluminum shield, causing the probable failure point to be the interface between the shield and the concrete. A stress analysis representation of the restrained shield in the concrete cradle is shown in Figure 2-4 on the following page.
