*Type A Accident Investigation  
of the December 8, 1999*

**Multiple Injury Accident  
Resulting from the  
Sodium-Potassium Explosion  
in Building 9201-5  
at the Y-12 Plant**

February 2000

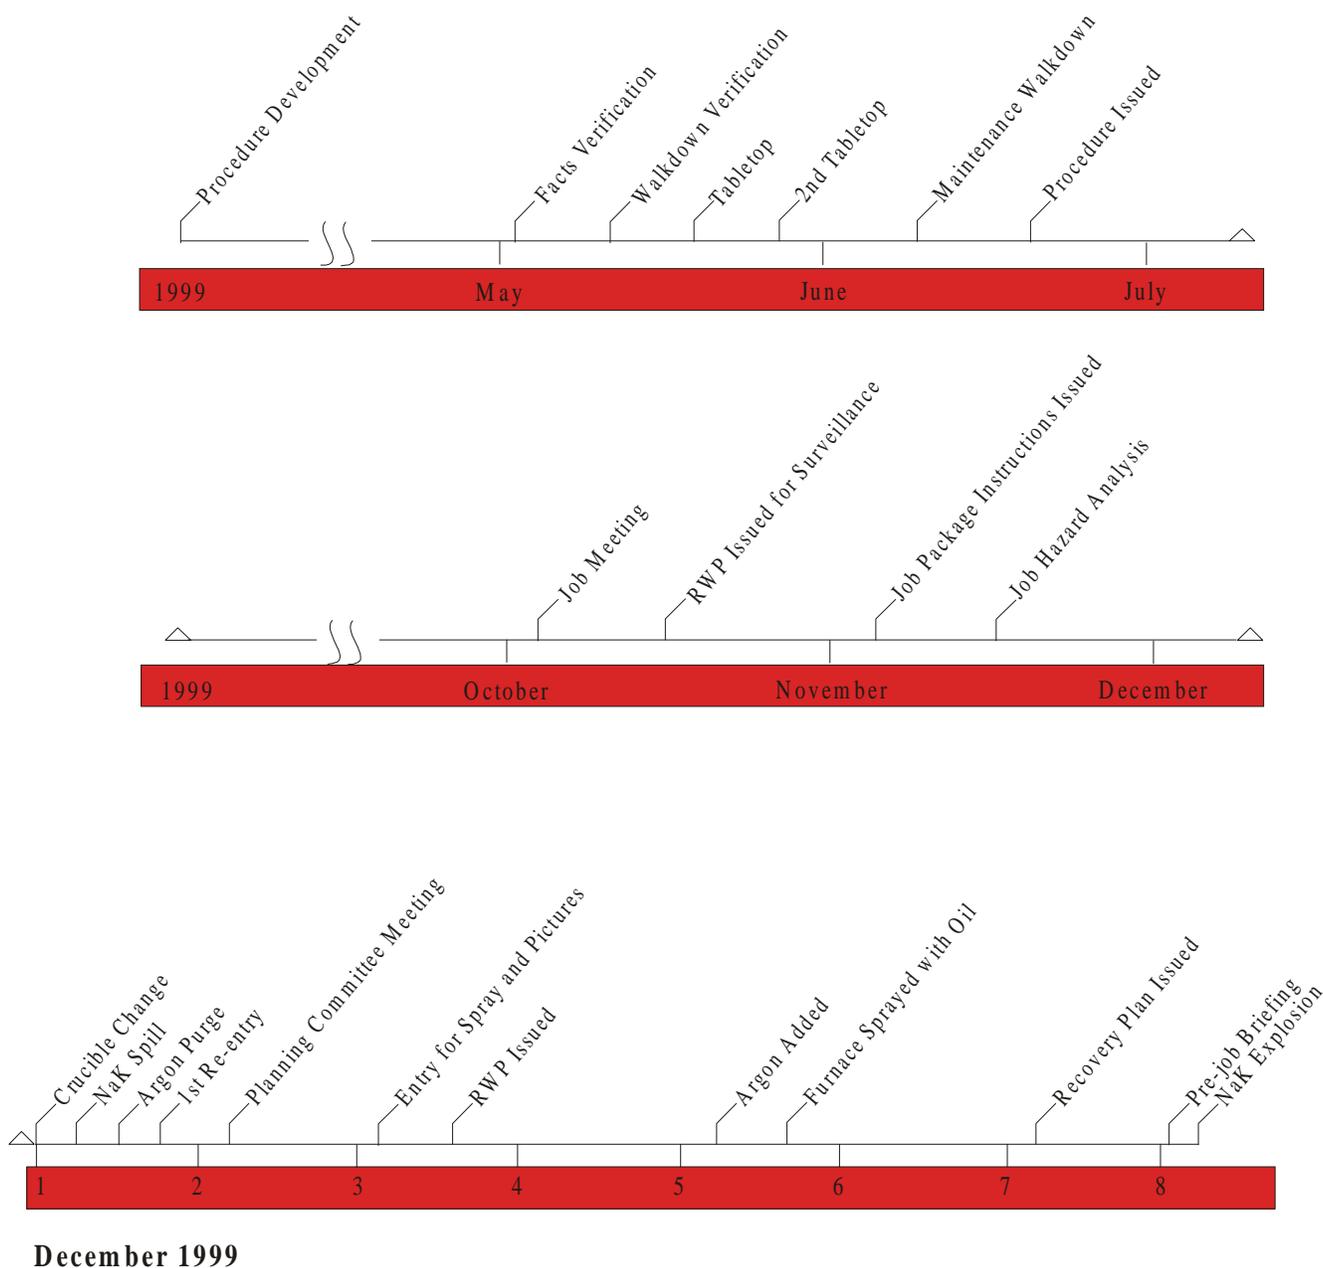
Figure 1. Activities Related to Development of the Crucible Changeout Procedure

Although the explosion and injuries occurred on December 8, the circumstances that led to the accident occurred on December 1, 1999, when NaK was inadvertently released during preparation for crucible changeout. This section describes the chronology of events leading up to the accident, the response to the accident, and the personnel injuries resulting from the accident. The event timeline is shown in Figure 1.

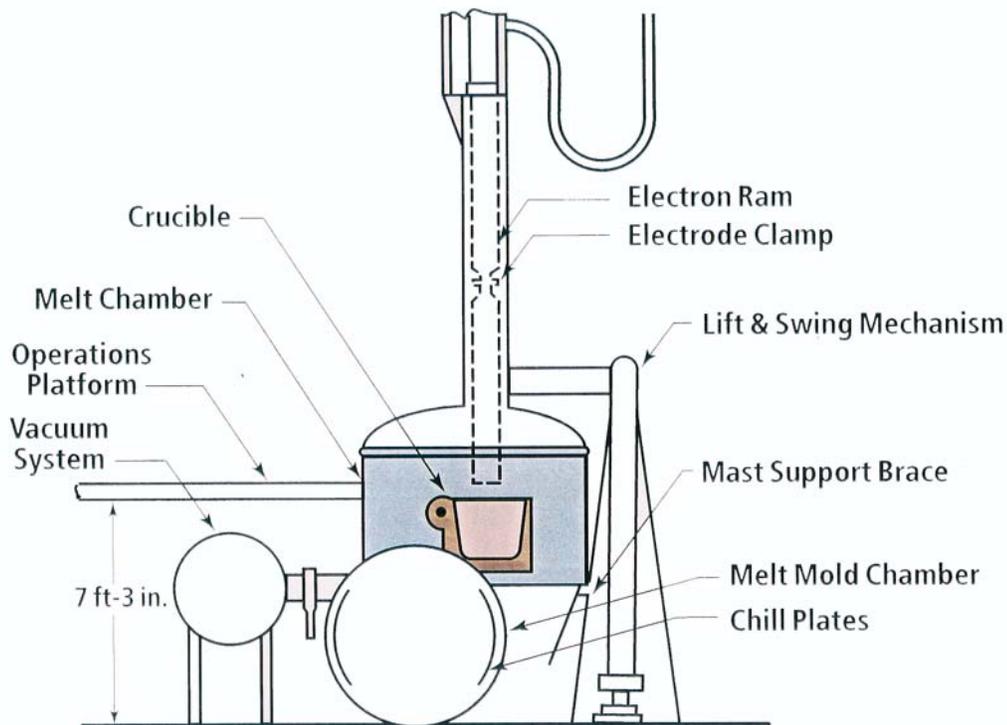
Figure 2. Skull Caster Furnace

In early 1999, Y-12 Plant management began planning to replace the steel crucible of the skull caster furnace (Figure 2). These crucibles experience heat stress during the arc melting process and need to be replaced (typically after about 70 melting cycles) to reduce the likelihood of a crucible failure during operations. The last crucible change occurred in 1993.

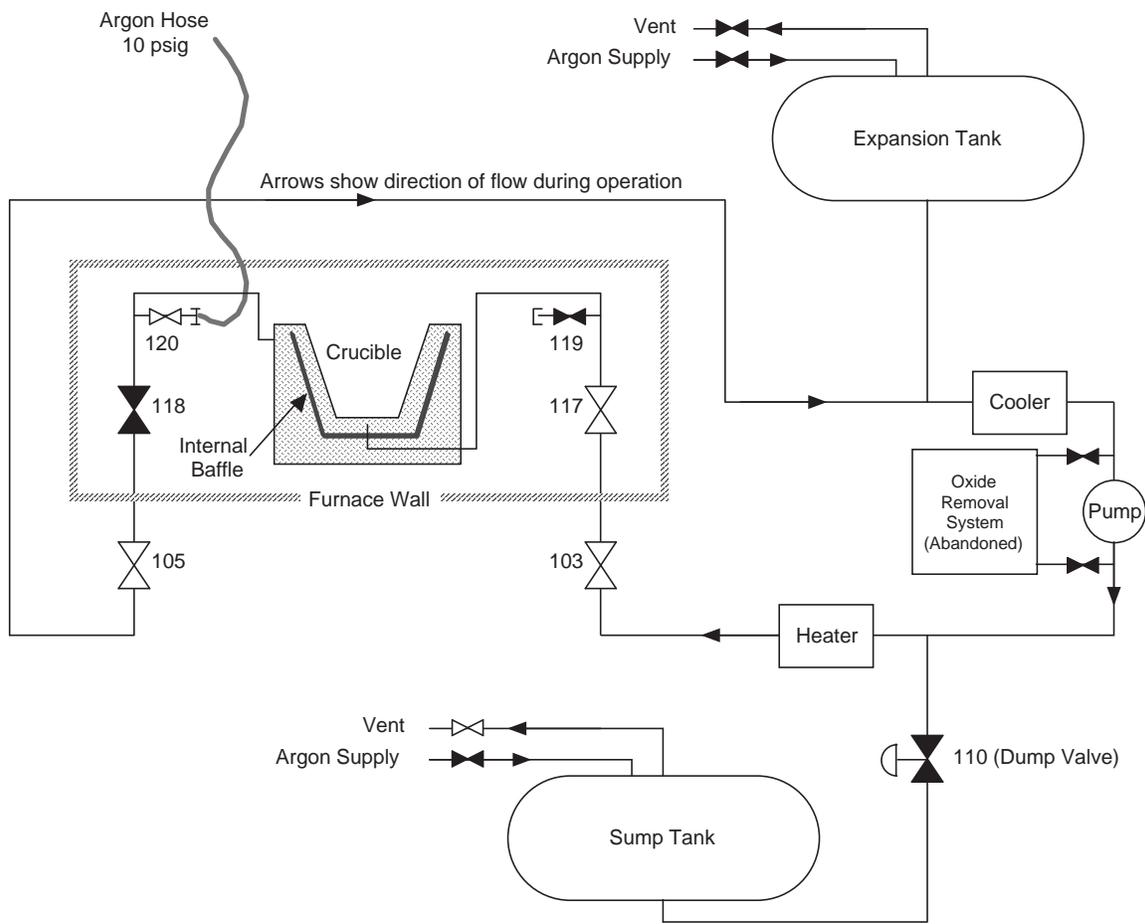
**Figure 3. Simplified NaK System Schematic**

Figure 3 (see page 10). The first portions of the procedure involved heating the NaK system to about 200 F to improve flow characteristics and then draining the expansion tank through the dump valve.

A combination of procedural errors (as discussed in Section 3.2) resulted in NaK spraying out the vent line. The spray of argon and NaK continued until the operators closed the NaK crucible isolation valves outside the furnace. Operators also closed the furnace lid and added argon to minimize the exposure of NaK to air. Oxides coated the walls and outside surfaces of the piping and furnace internals. Y-12 Plant personnel estimate that about three to ten gallons of NaK were spilled (although the estimates vary considerably).

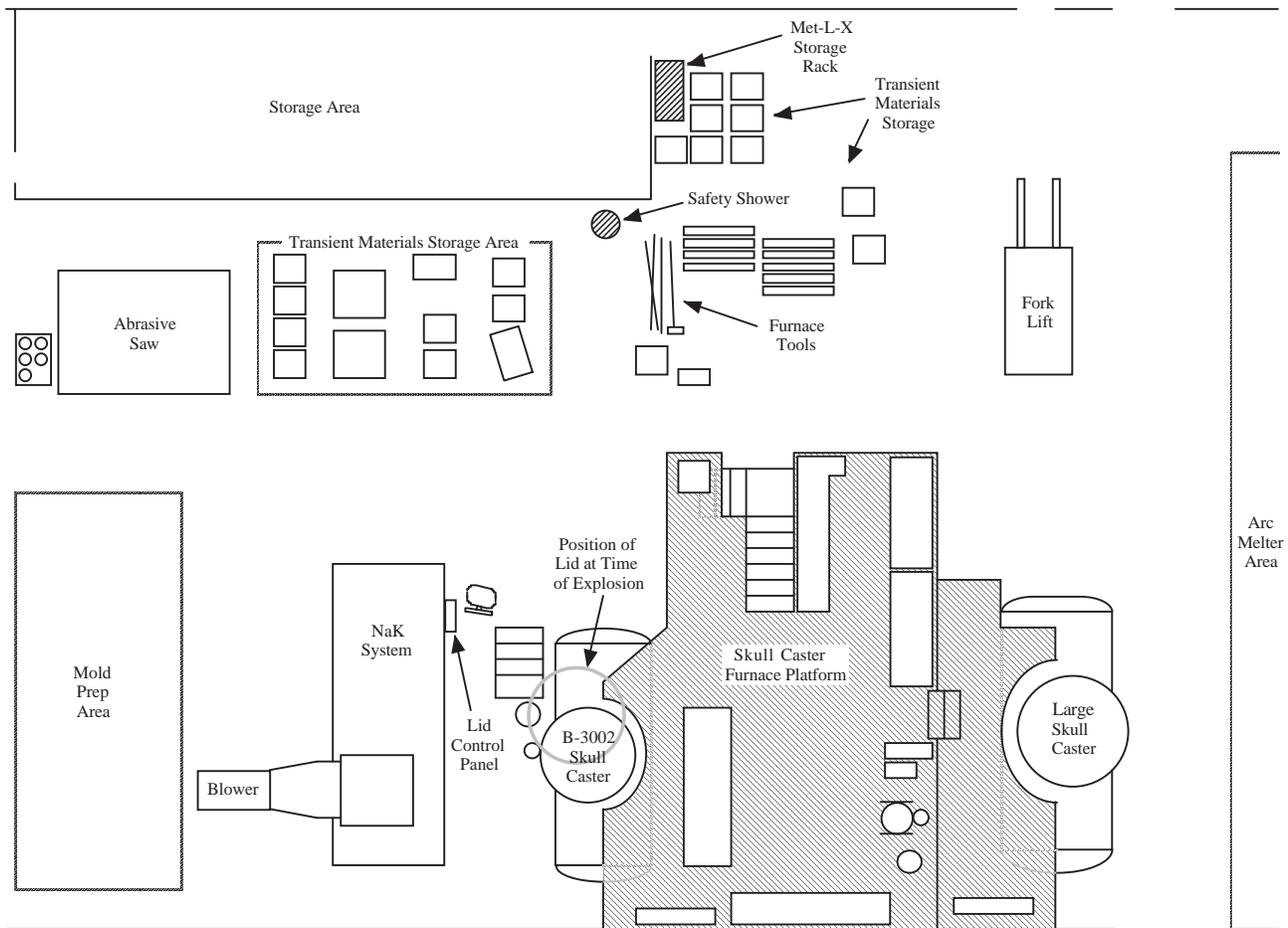
**Figure 4. Skull Caster Furnace Area, Showing Position of Safety Showers**

The layout of Building 9201-5 is shown in Figure 4. At the time of the explosion, the ten workers were positioned as marked on Figure 5.

Although suffering from burns, three team members (OM-1, CO-3, and CO-4) returned to the furnace area to close the lid and extinguish small spot fires using dry chemical extinguishers. Another worker (FS-2) cleaned up water from the safety showers, which was accumulating on the floor (there are no berms or drains around the safety shower that is nearest the furnace). The water had spread in the direction of furnace and was reacting with NaK that had been dispersed onto the concrete floor by the explosion. Another DUO worker not involved in the recovery plan heard the noise and provided assistance when the accident occurred.

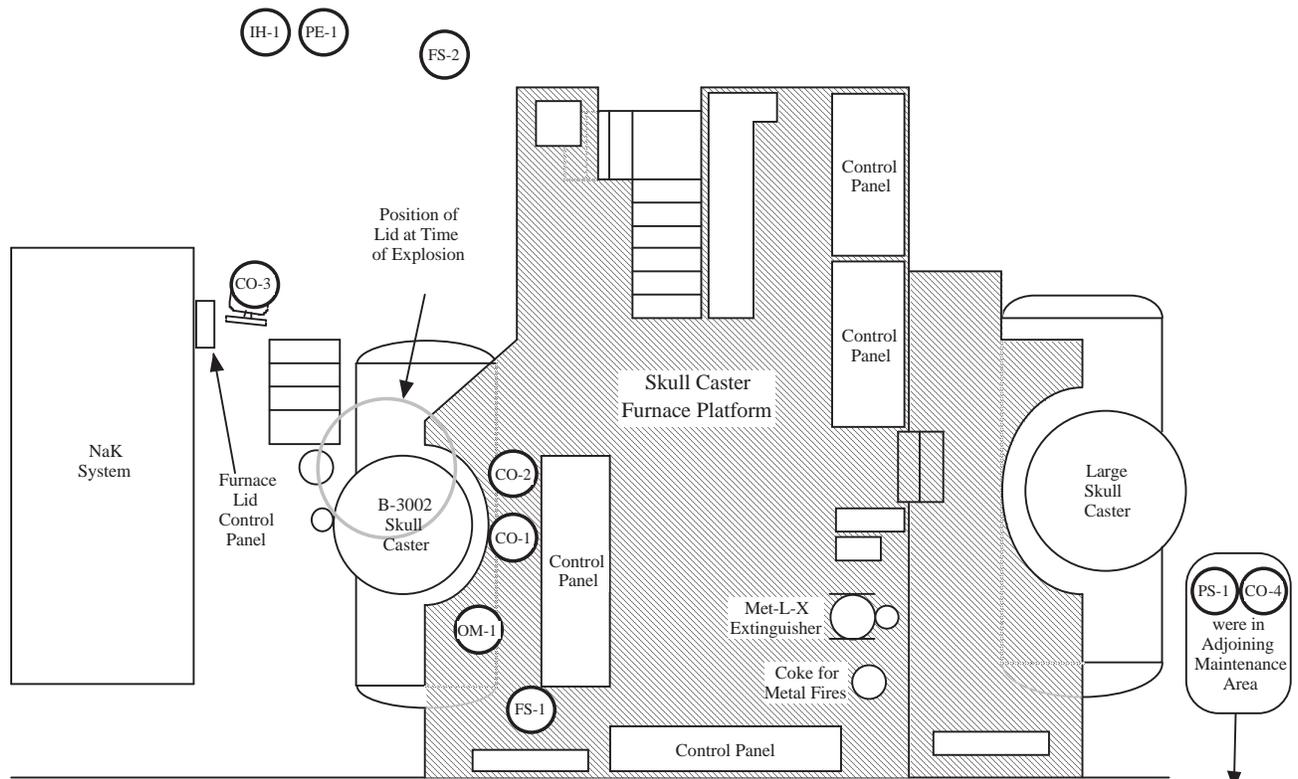
**Figure 5. Skull Caster Furnace Area, Showing Positions of Workers at the Time of the Explosion**

The workers on the platform left as rapidly as possible. The operations manager (OM-1) helped the most severely injured worker (CO-1) off the platform and held him in an effort to smother his burning coveralls as they proceeded to the safety shower. Other workers discarded burning clothing as they left the area. The workers assisted the injured personnel and extinguished small fires. One worker (IH-1) exited the area and called 911, which connects to the Y-12 fire department dispatcher.

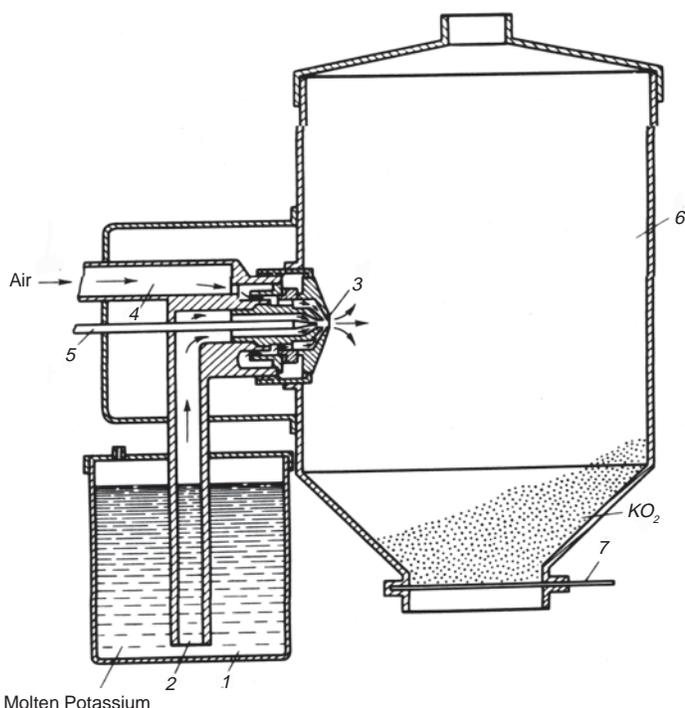
### Figure 6. Commercial Production of Potassium Superoxide

The initial spill on December 1, 1999, involved a failure to close a valve, resulting in NaK spraying into the crucible while under pressure and at elevated temperatures. These conditions—forced exposure to air at elevated temperature—were favorable for the formation of potassium superoxide. Spraying NaK into the air in this manner is similar to the process used for commercial production of potassium superoxide, although commercial processes would use a higher temperature and a controlled fine spray (see Figure 6 on page 19).

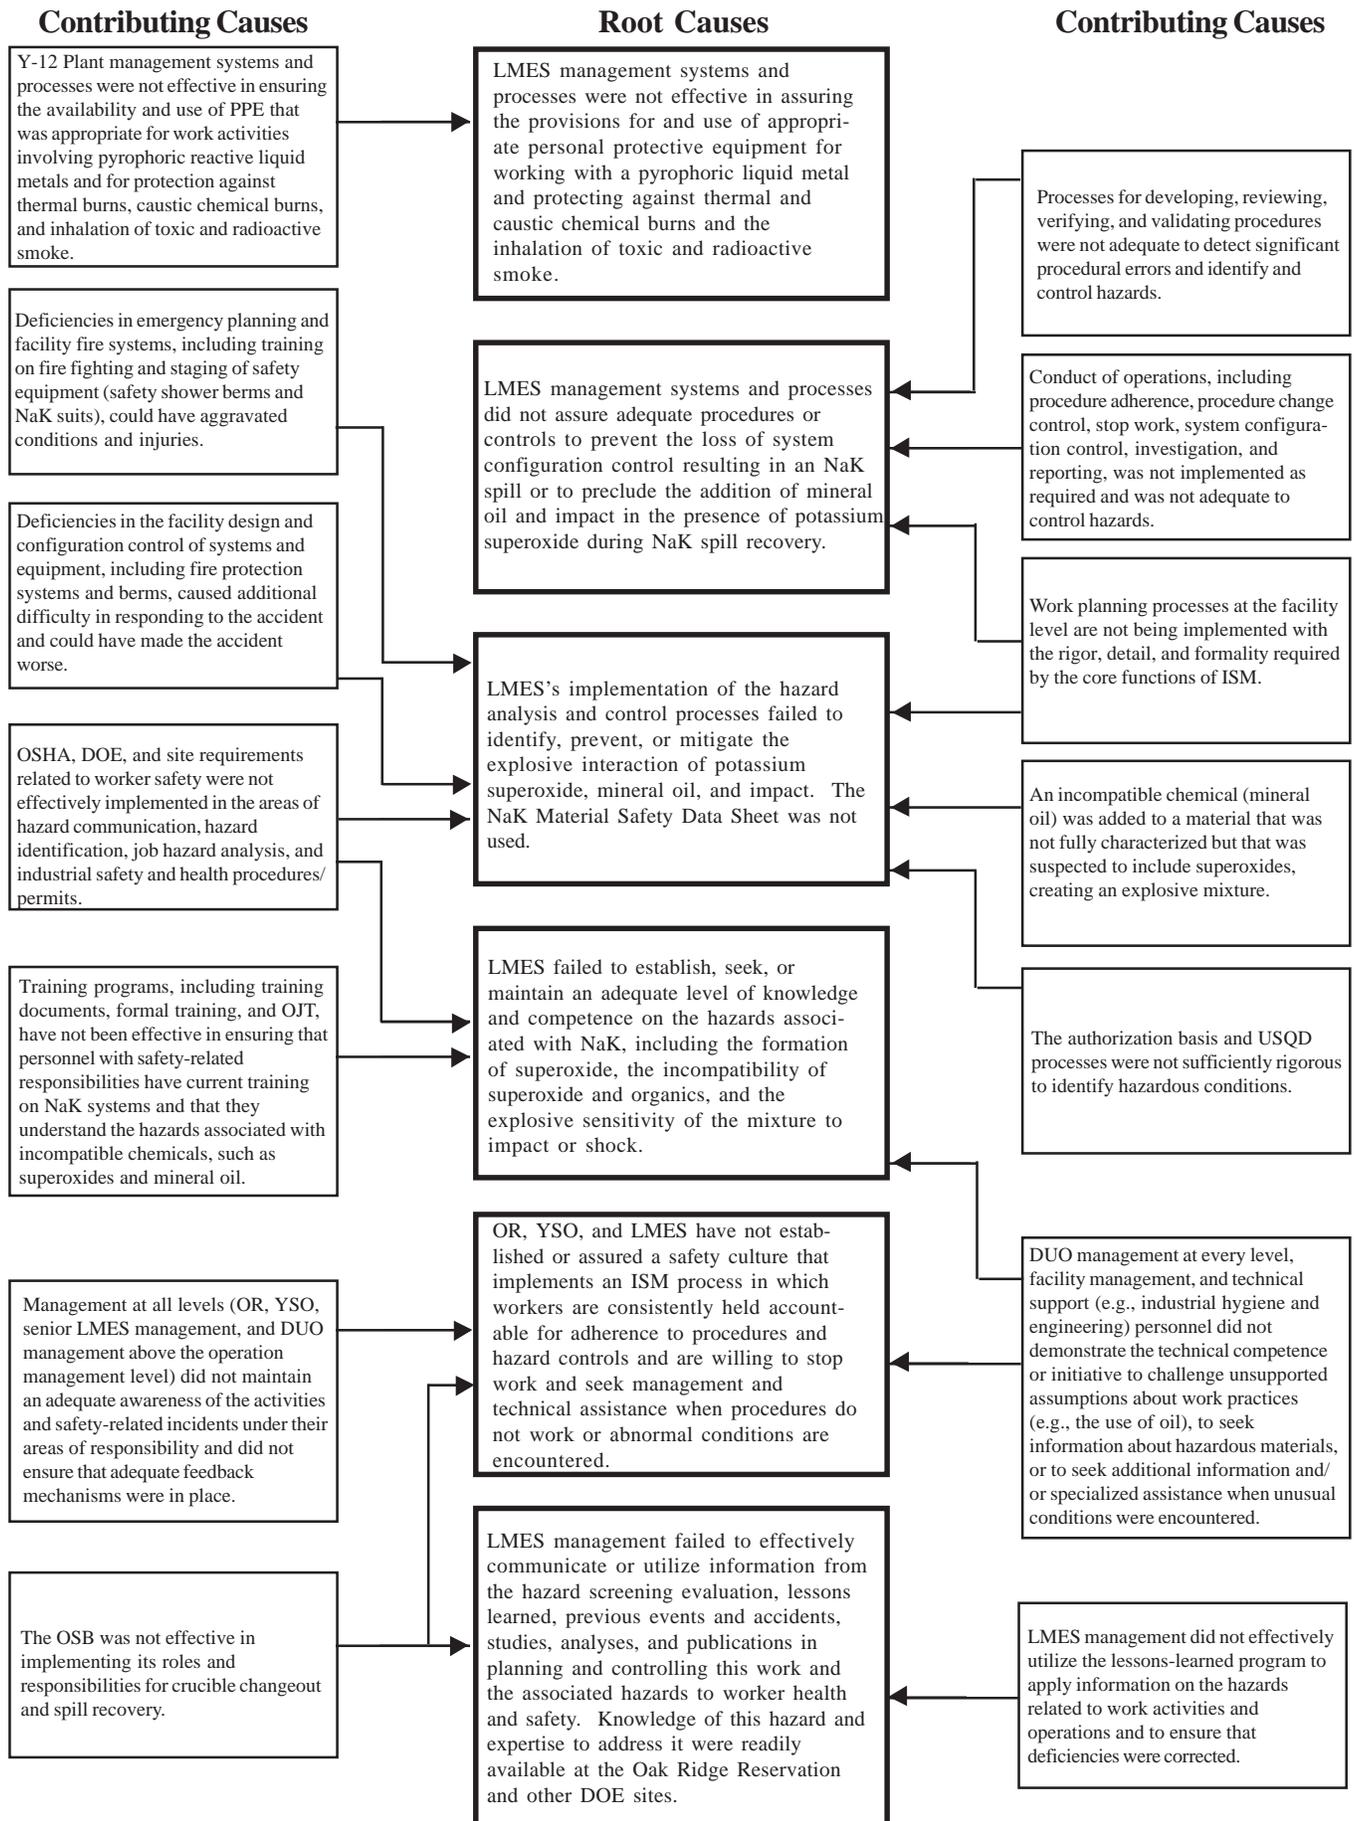
Figure B-1. Root and Contributing Causes

<b>Root Causes</b>	<b>Discussion</b>
<p>LMES's management systems and processes were not effective in assuring the provisions for and use of appropriate personal protective equipment for working with a pyrophoric liquid metal and protecting against thermal and caustic chemical burns and the inhalation of toxic and radioactive smoke.</p>	<p>Appropriate PPE that could have prevented or reduced the severity of the injuries, including thermal burns, chemical burns, and toxic chemical and radiological uptakes, is defined in LMES accident lessons-learned documents, OSHA requirements, and NaK MSDSs. The selection of PPE on the day of the accident or for other preliminary activities was not based on these requirements or on sound and documented analyses.</p>

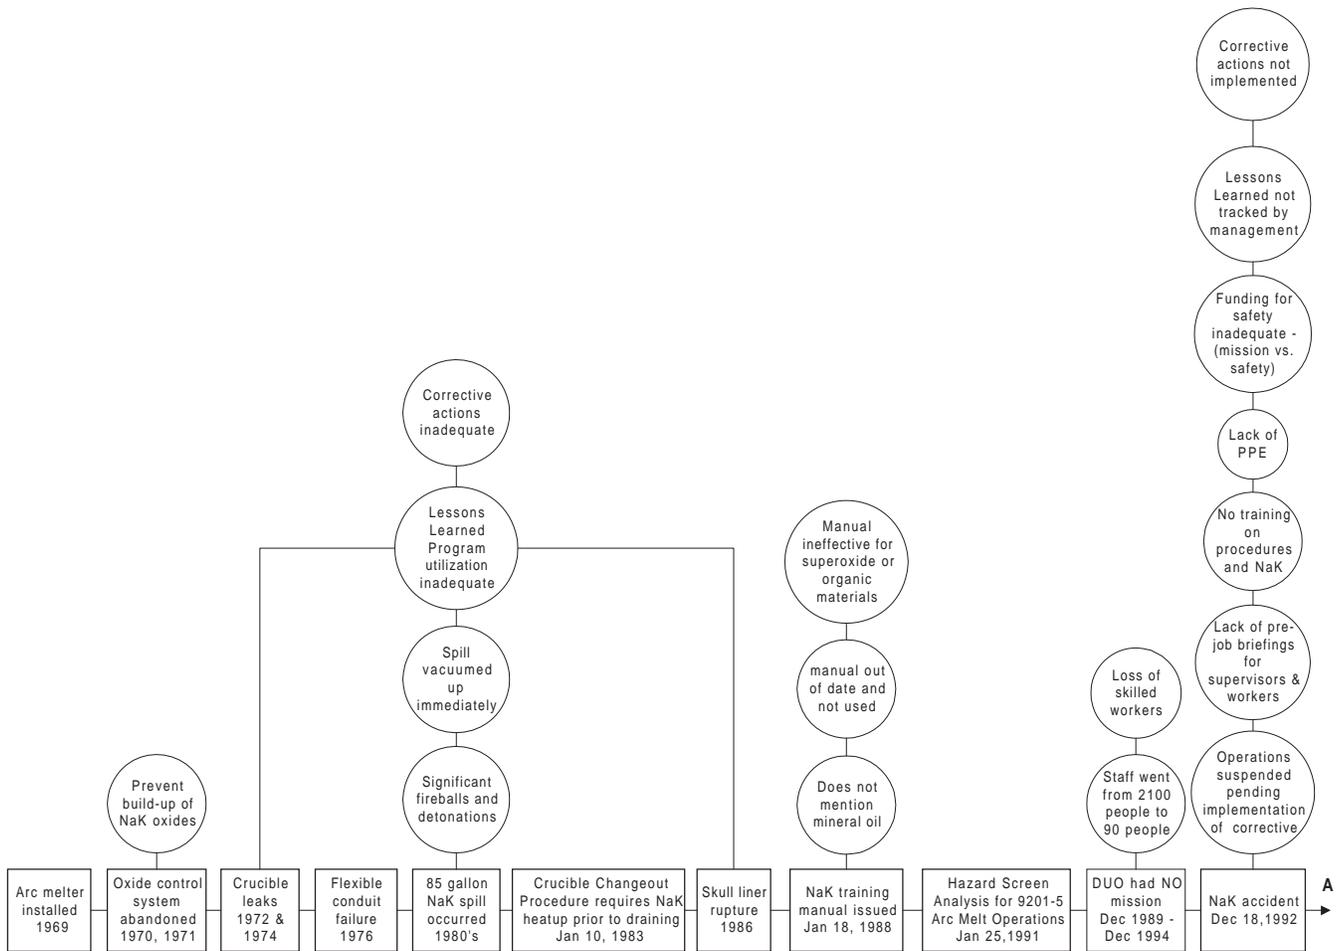
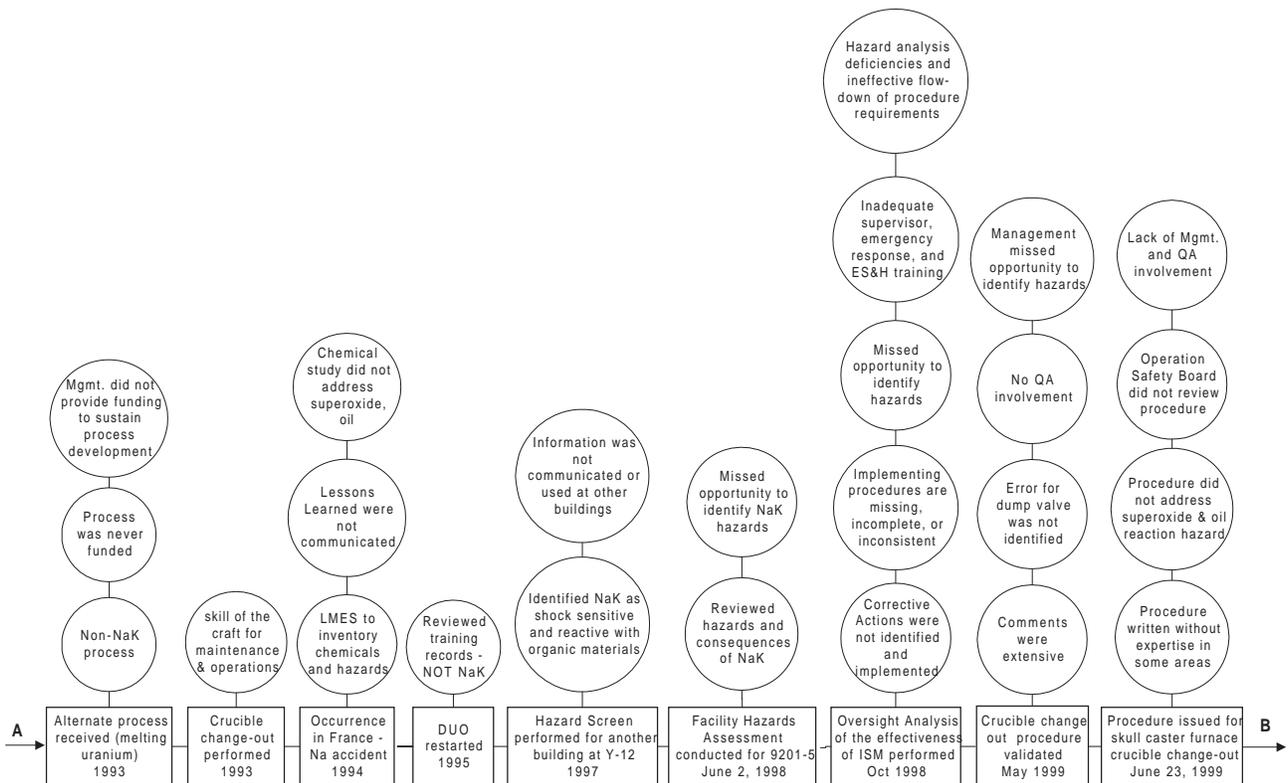
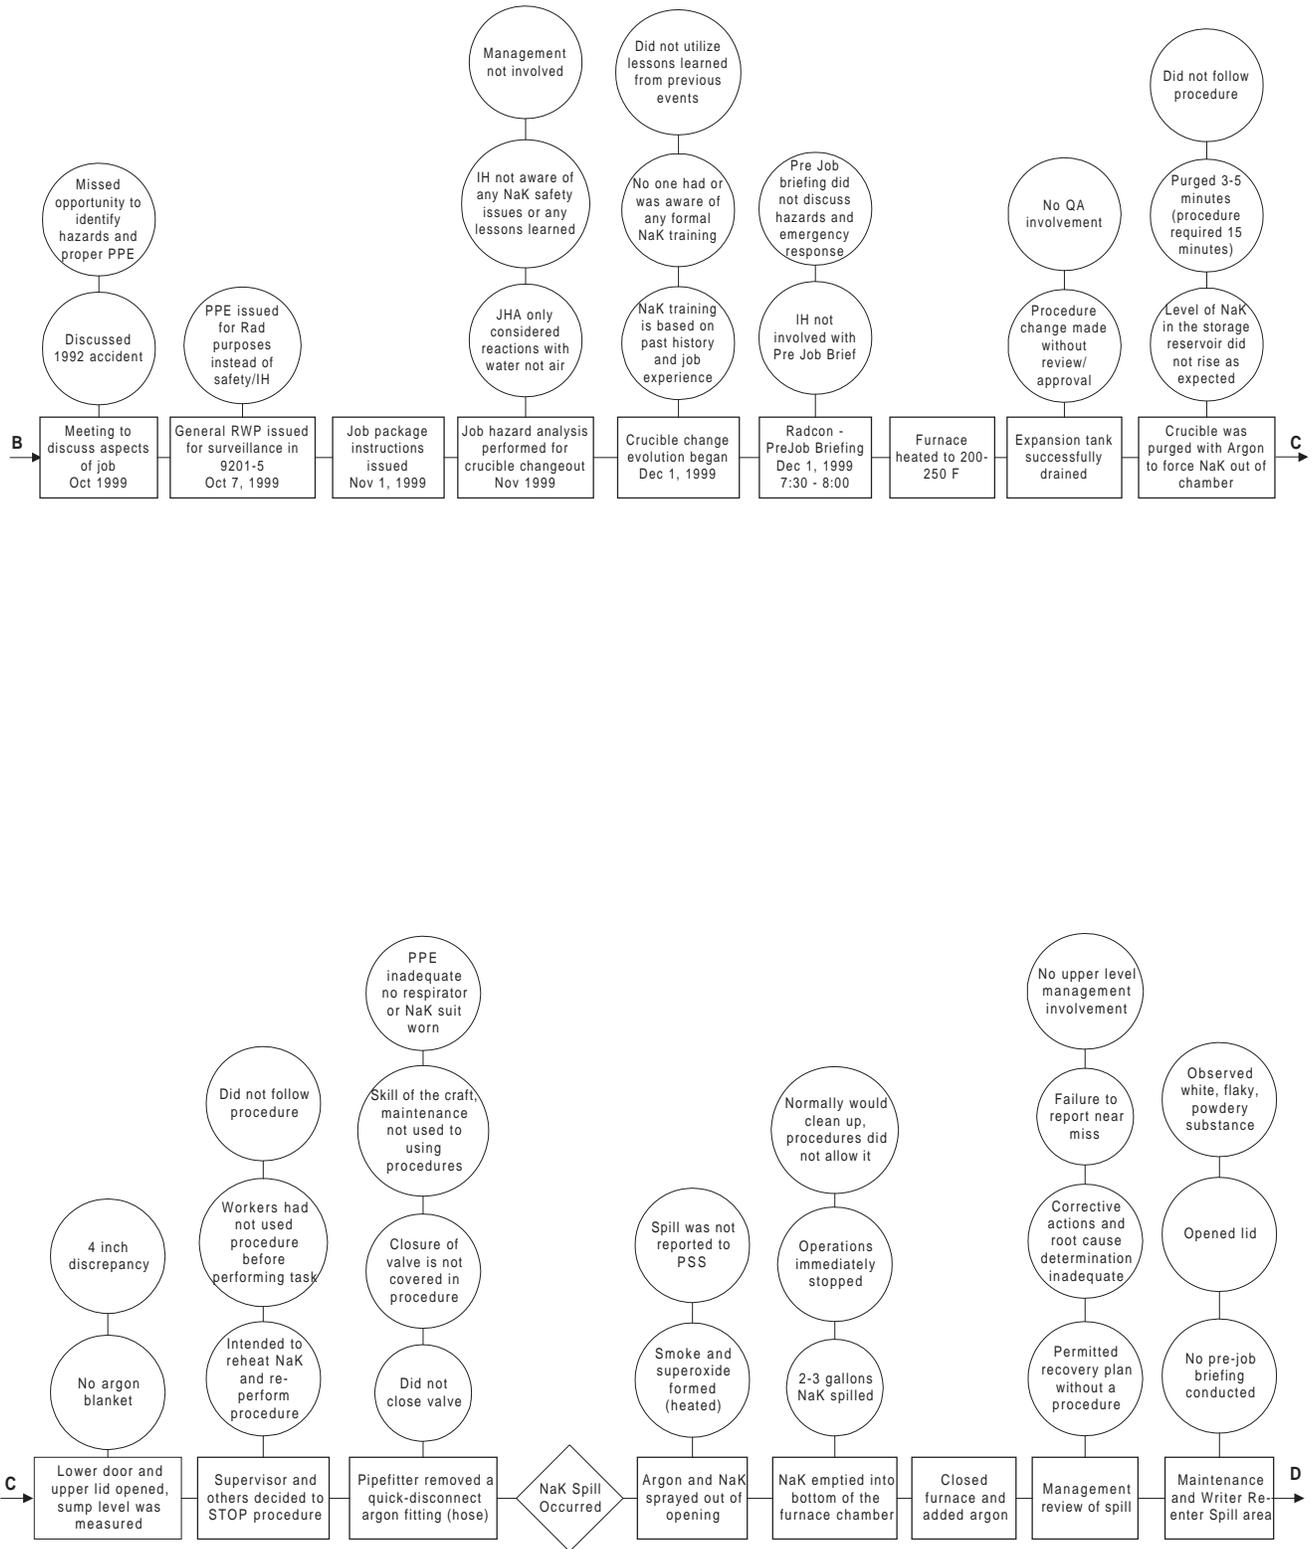
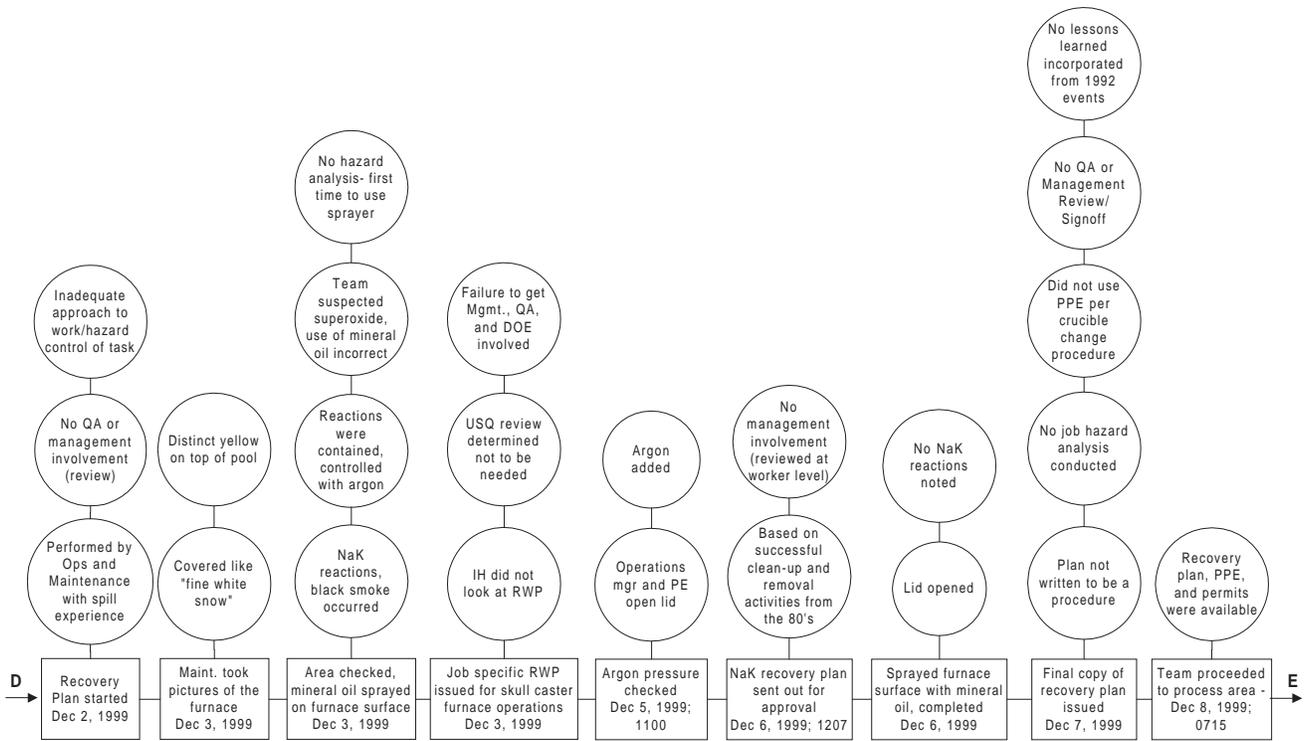
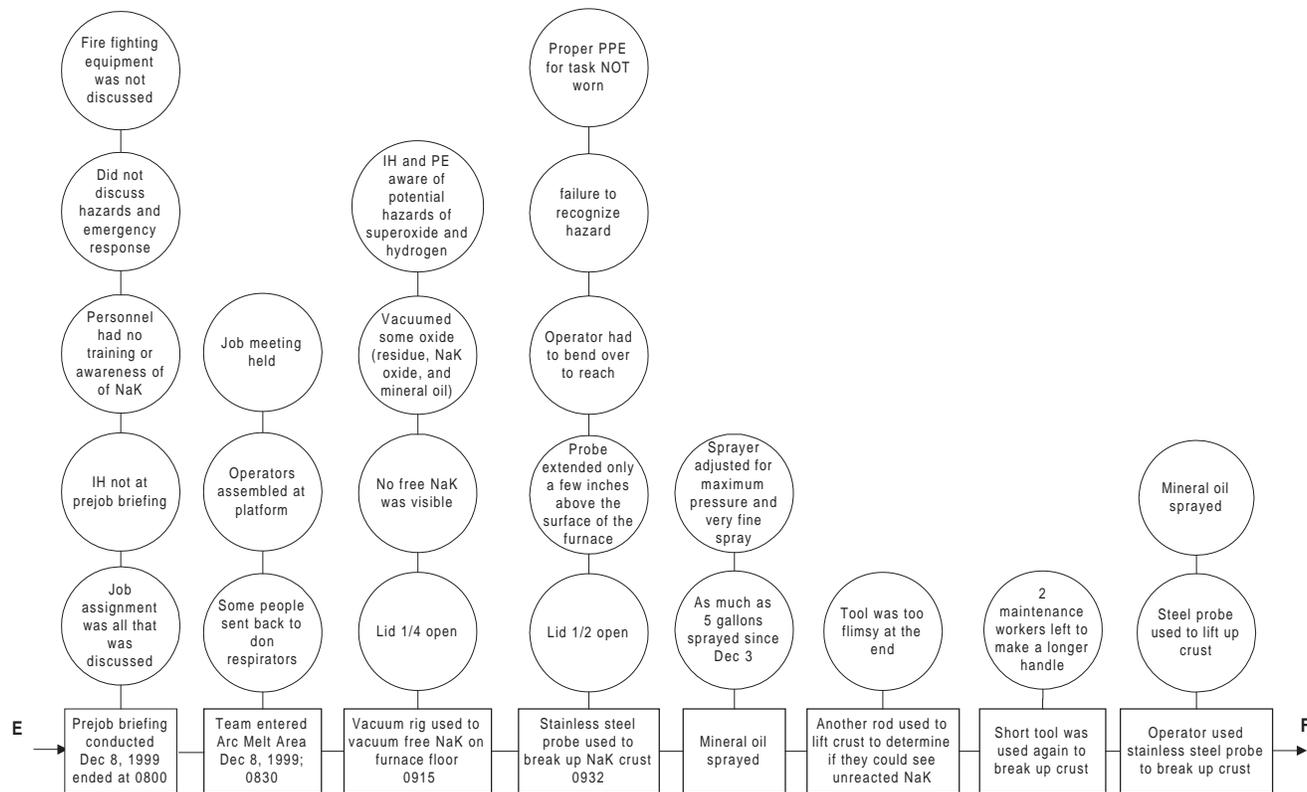
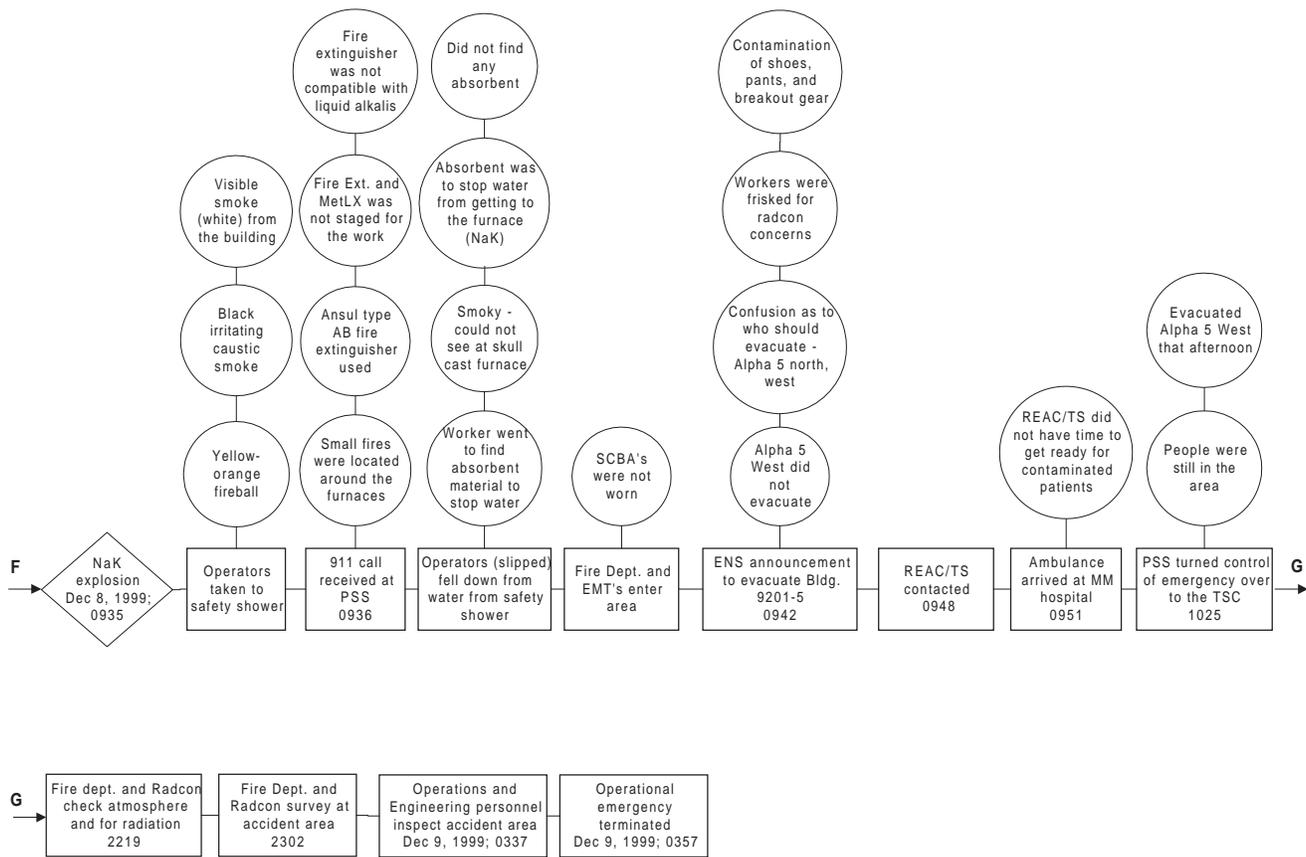
**Figure B-2. Events and Causal Factors Chart**

**Events and causal factors analysis** includes charting, which depicts the logical sequence of events and conditions (causal factors) that allowed the event to occur, and the use of deductive reasoning to determine events or conditions that contributed to the accident.
