U.S. CHEMICAL SAFETY AND HAZARD INVESTIGATION BOARD

# INVESTIGATION REPORT

## COMBUSTIBLE DUST FIRE AND EXPLOSIONS

**CTA ACOUSTICS, INC.**

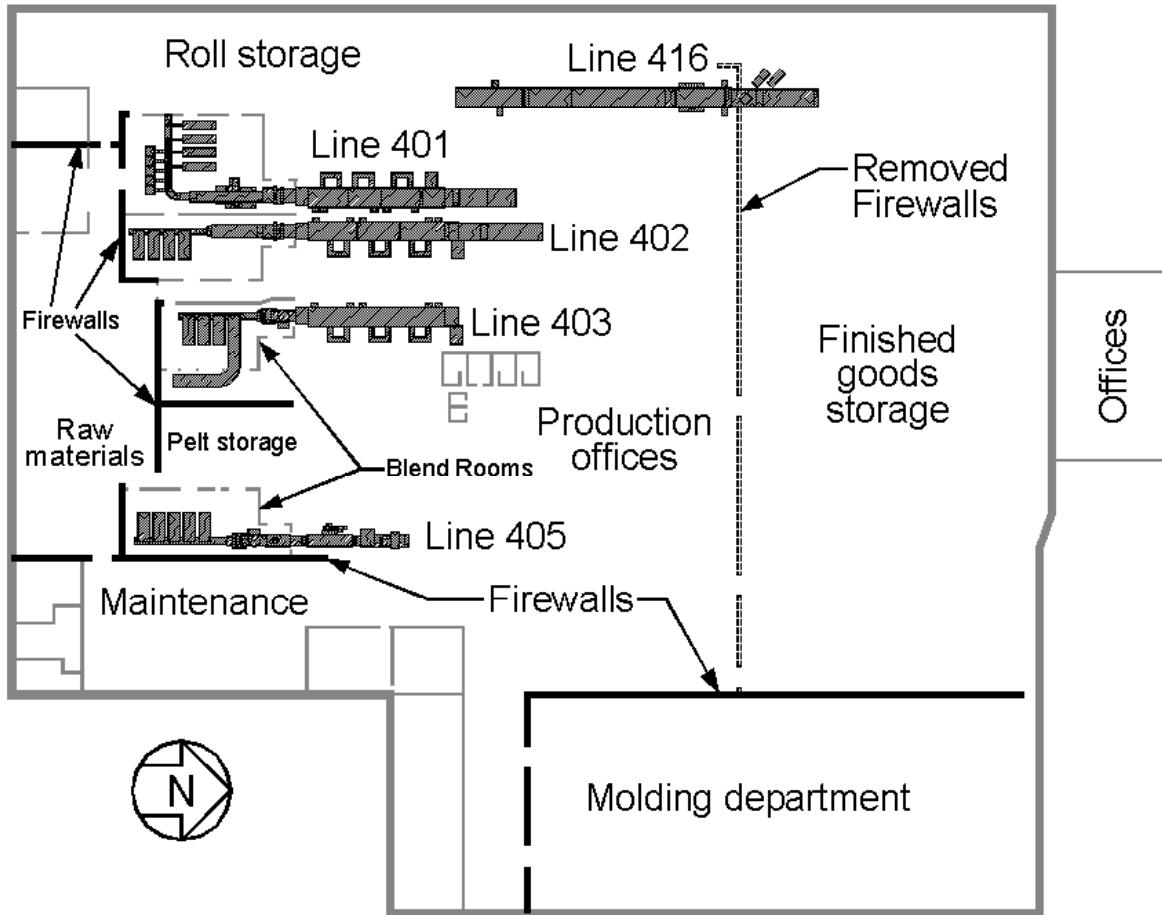
Figure 1. Simplified layout of CTA facility.

Four production lines—401, 402, 403, and 405—were located in the center portion of the southern half of the plant. Production line 416 was located near the west wall (Figure 1). The production lines included material feeders, separating and mixing machines, curing ovens, and trimming equipment connected by conveyors. Lines 401, 402, and 403 were adjacent to each other; line 405 was approximately 80 feet east of line 403. The open area between lines 403 and 405 was used to store racks of semi-cured acoustical insulation, referred to as “pelts.” The molding department, where hydraulic molding presses and water jet cutters were used to shape and size the automotive insulation products, was located in the northeast quadrant of the plant.

Firewalls to the south segregated the production lines from raw materials storage. A firewall also segregated the southeast portion of line 405 from the maintenance shop. This configuration created a 5- to 8-foot-wide aisle between the firewall and the east side of line 405. Another firewall, which ran from south to north in the open area between lines 403 and 405, partially segregated these lines. There was no firewall on the west side of the production area. In late 2002, CTA removed firewalls on the north side of the production area that segregated that area from the finished goods storage area. The Kentucky Department of Housing, Buildings, and Construction (which became the Kentucky Office of Housing, Buildings, and Construction in 2004) approved removal of these firewalls.

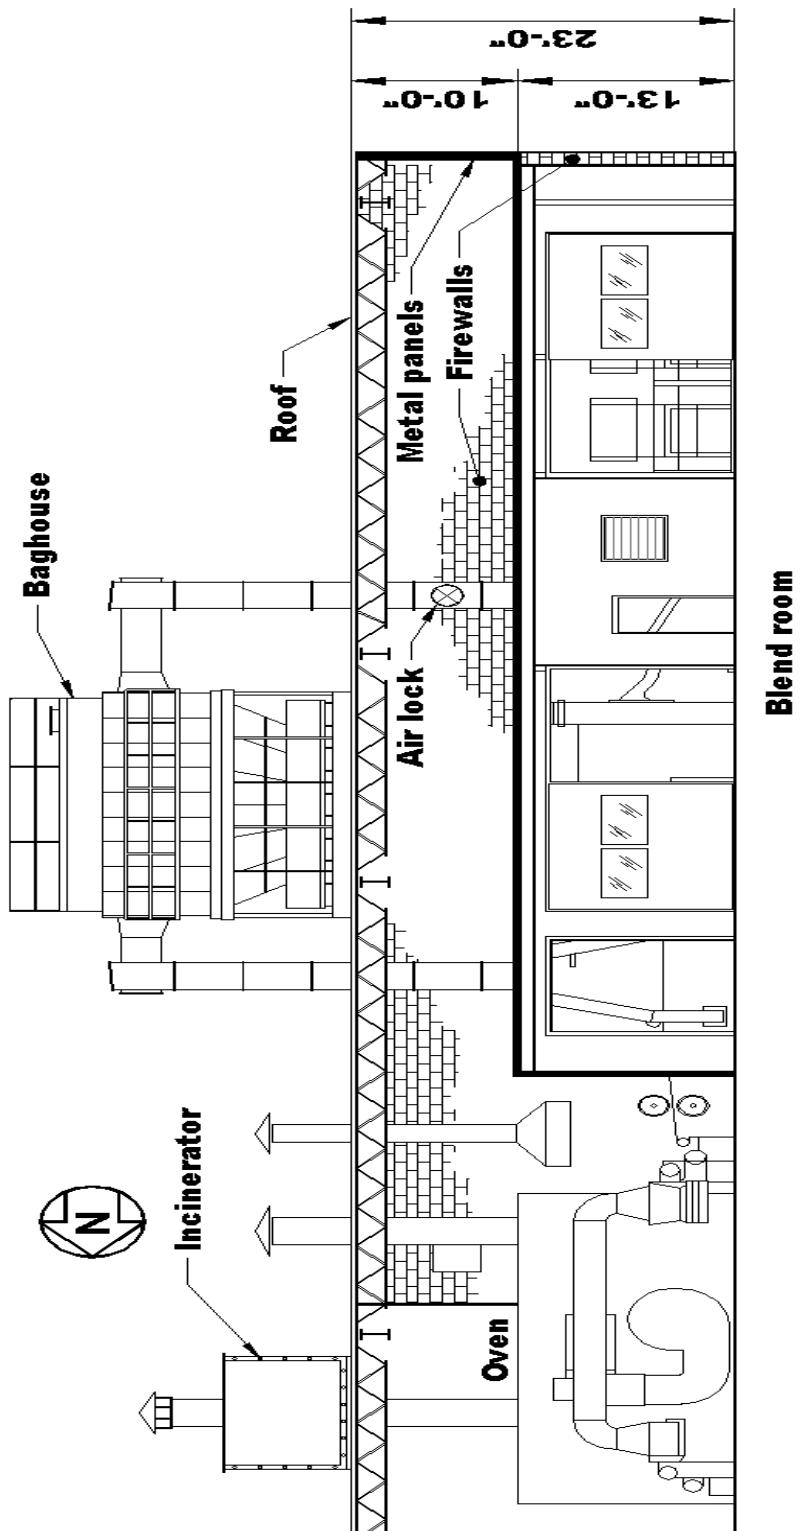
Figure 2. Side view showing location of line 405 blend room.

Thirteen-foot-high freestanding enclosures, called “blend rooms,” covered processing equipment on the south end of four production lines. Figure 2 shows the location of the blend room in a side view of line 405. Blend room ceilings were constructed of metal panels with recessed fluorescent light fixtures. The areas between the roofs of the blend rooms and the plant roof were generally open on two or three sides.

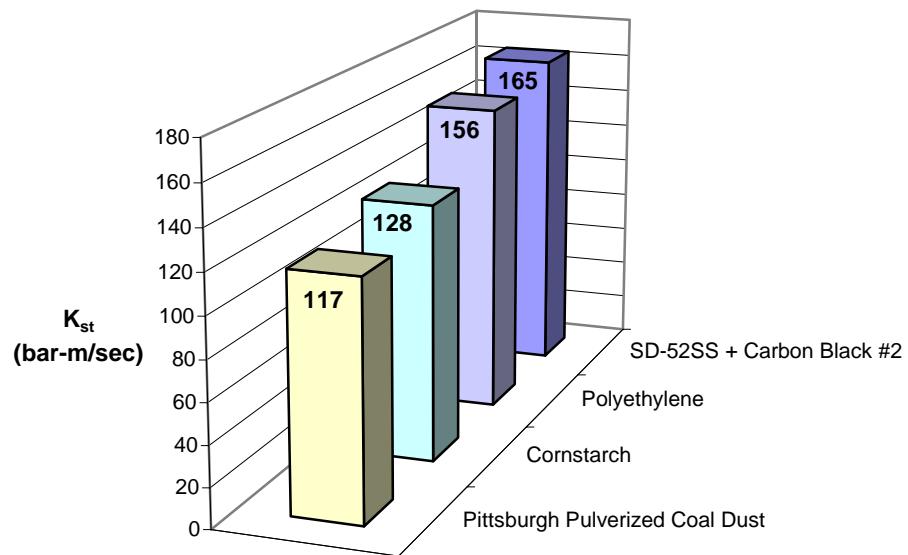
Figure 14. Explosion severity of Durite SD-52SS compared with other common combustible dusts.

Test data from the resin samples were also compared to the explosion characteristics of other common combustible dusts—namely, Pittsburgh coal dust, polyethylene dust, and cornstarch. Figure 14 shows that the Borden Chemical black phenolic resin used at CTA has a higher  $K_{st}$  value than the other dusts.

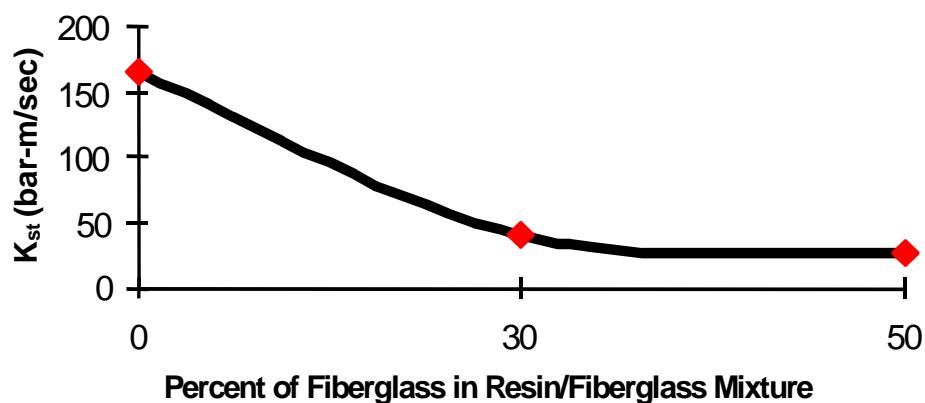
Figure 15. Explosivity testing results for resin/fiberglass mixtures.

Dust that settled in the CTA production area was typically a mixture of phenolic resin and small fiberglass fibers. Samples of ground fiberglass and phenolic resin were mixed in varying percentages in the CSB contractor's laboratory and tested. The test results show that as the fiberglass content increased, the mixtures remain explosive, but explosion severity decreased (Figure 15).

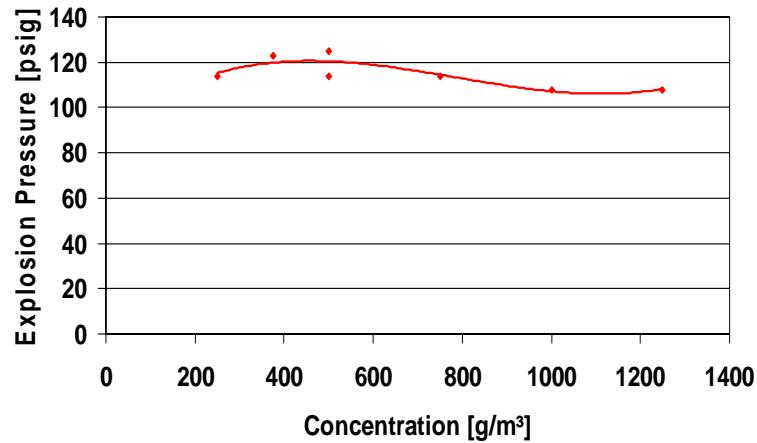
Figure B-1. Durite SD-52SS overpressure versus concentration.

Figures B-1 and B-2 show test overpressures and rates of pressure rise as a function of concentration, respectively. The highest values of each over the entire concentration range determined  $P_{\max}$  and  $(dP/dt)_{\max}$ . For comparison, Figure 14 (Section 7.2) shows explosion severity data for polyethylene, Pittsburgh coal dust, and cornstarch.

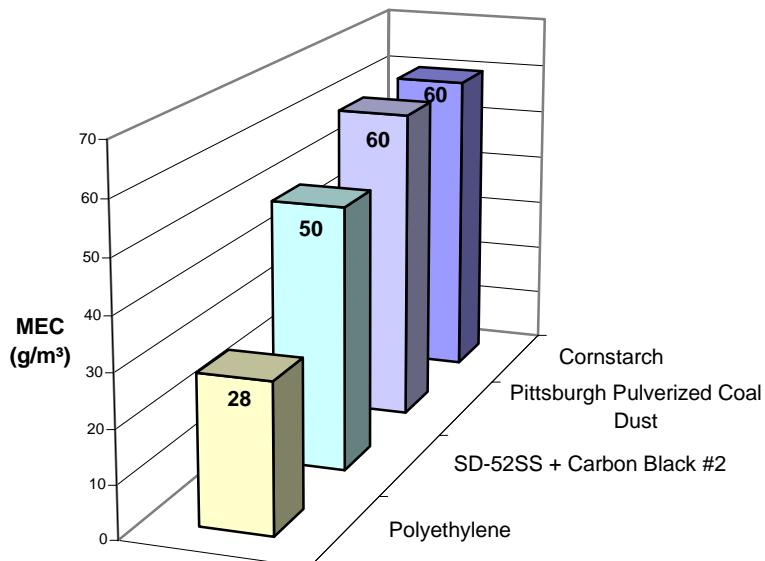
Figure B-3. Minimum explosive concentration of Durite SD-52SS compared with other common combustible dusts.

Figure B-3 compares MECs for the Borden Chemical SD-52SS phenolic resin, Pittsburgh coal dust, polyethylene dust, and cornstarch.

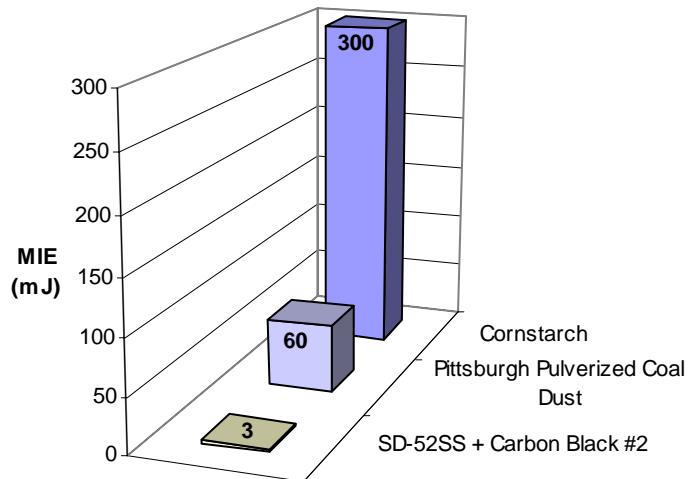
Figure B-4. Minimum ignition energy of Durite SD-52SS compared with other common combustible dusts.

Figure B-4 shows MIE test results for a Durite SD-52SS dust cloud in air. Results indicate that the phenolic resin is very easy to ignite, requiring only 3 millijoules (mJ) of energy to initiate an explosion.
