U.S. Chemical Safety and Hazard Investigation Board

Hoeganaes Corporation: Gallatin, TN Metal Dust Flash Fires and Hydrogen Explosion

January 31, 2011; March 29, 2011; May 27, 2011

No. 2011-4-I-TN

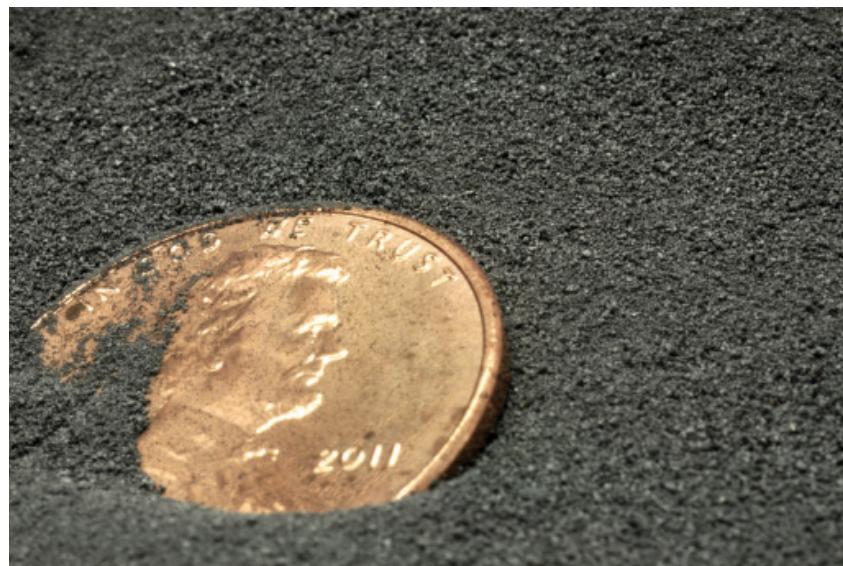
FIGURE 2

In the process of going through the furnace, the coarse powder becomes a thick sheet called “cake.” The cake is sent to a cake breaker and ultimately crushed into the fine PM product. The majority of the finished PM product has a particle diameter between 45-150 microns, or roughly the width of a human hair (Figure 2).

Fine PM collected from the Hoeganaes plant (penny shown for scale).

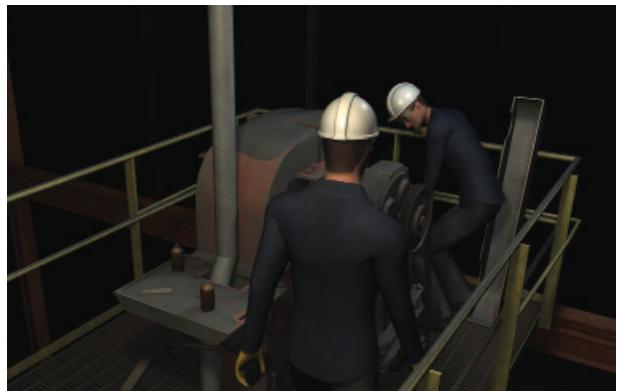
**FIGURE 4 (RIGHT)**

Scene of January 31, 2011, incident area.

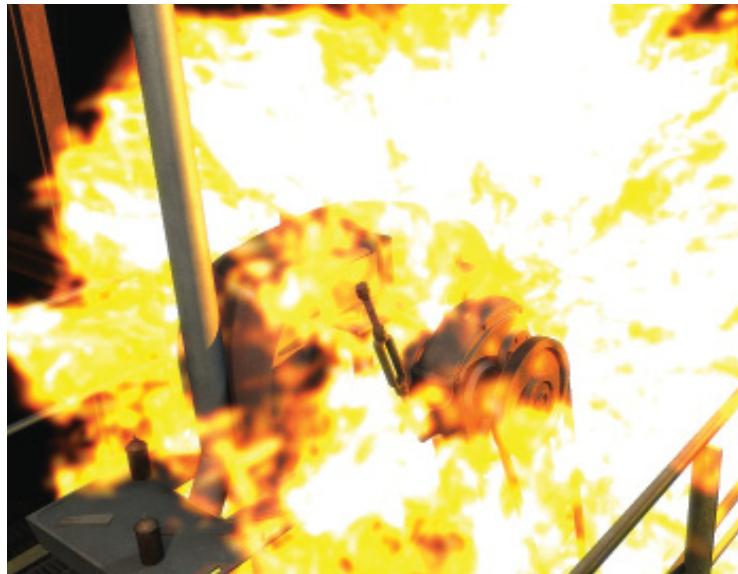
FIGURE 5

Based on their observations, they did not believe that the belt was off-track and requested, via radio, that the operator in the control room restart the motor (Figure 4). When the elevator was restarted, vibrations from the equipment dispersed fine iron dust into the air. During a CSB interview, one of the workers recalled being engulfed in flames, almost immediately after the motor was restarted.

Computer graphic of January 31 iron dust flash fire.

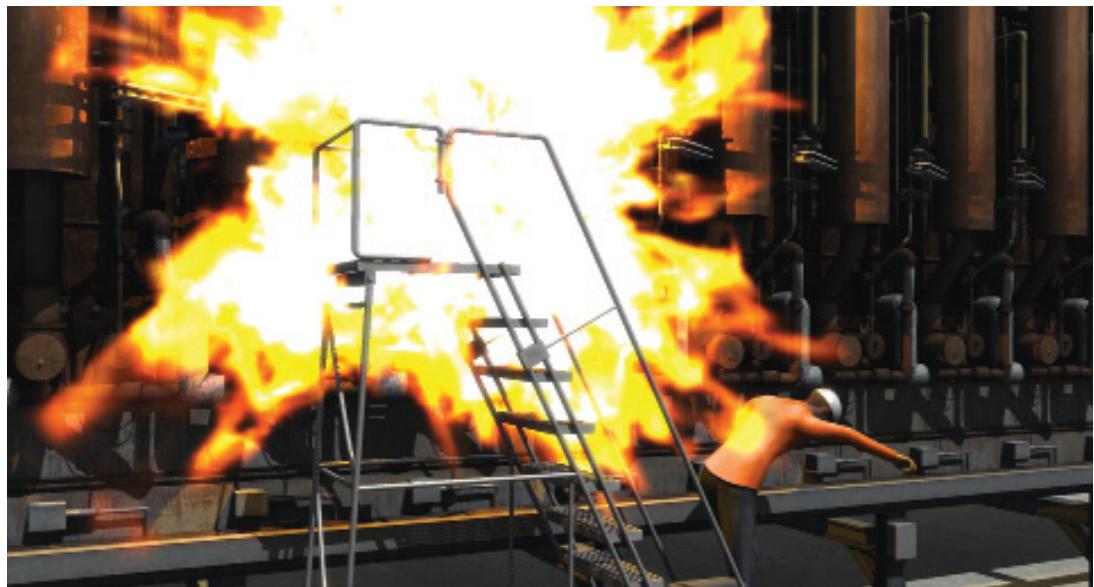
**FIGURE 8**

Computer graphic of March 29 iron dust flash fire.

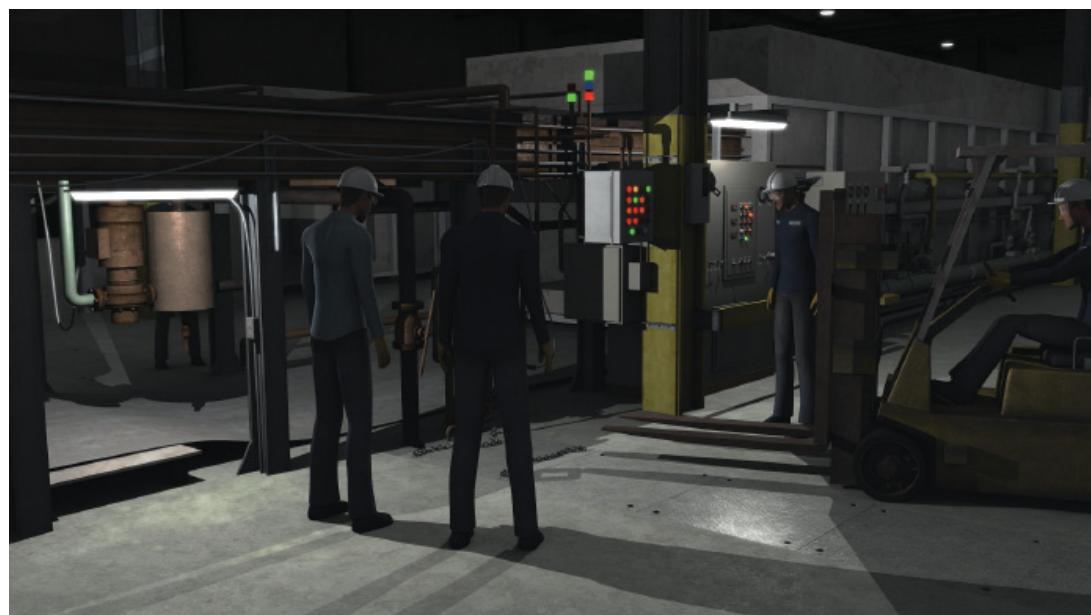
Computer graphic of maintenance crews starting to remove the trench covers using a forklift just prior to May 27 explosion.

covers were too difficult to lift without machinery. Using an overhead crane, they were able to remove some of the trench covers. They determined that the leak was near the southernmost trench covers, which the crane could not reach. Shortly after 6:30 am, maintenance personnel acquired a forklift equipped with a chain on its forks, and were able to reach and begin removing the southernmost trench covers.

Interviews with eyewitnesses indicate that just as the first trench cover was wrenched from its position by the forklift, friction created sparks, followed by a powerful explosion. Several days after the explosion, CSB investigators observed a large hole (approximately 3 x 7 inches) in a corroded section of piping that carried hydrogen and ran through the trench (Figure 11).

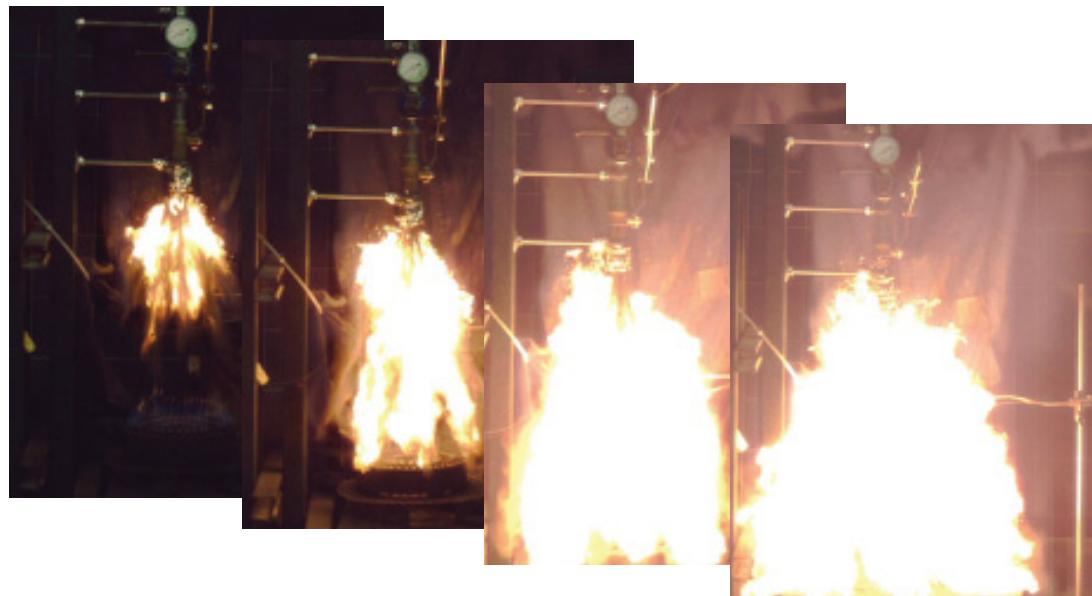
FIGURE 14

This test dispersed about 30 grams of iron dust—sampled from the baghouse⁹ associated with the bucket elevator from the January 31, 2011, incident—above an 8 inch burner. Upon being released, the dust auto-ignites in air due to the heat given off from the burner below (Figure 14). An intense white flame was produced that reached a peak diameter of 18 inches.

CSB iron dust combustibility demonstration, see Section 4.1.1.1.
