U.S. CHEMICAL SAFETY AND HAZARD INVESTIGATION BOARD

ALUMINUM DUST EXPLOSION

HAYES LEMMERZ INTERNATIONAL—HUNTINGTON, INC.

REPORT NO. 2004-01-I-IN

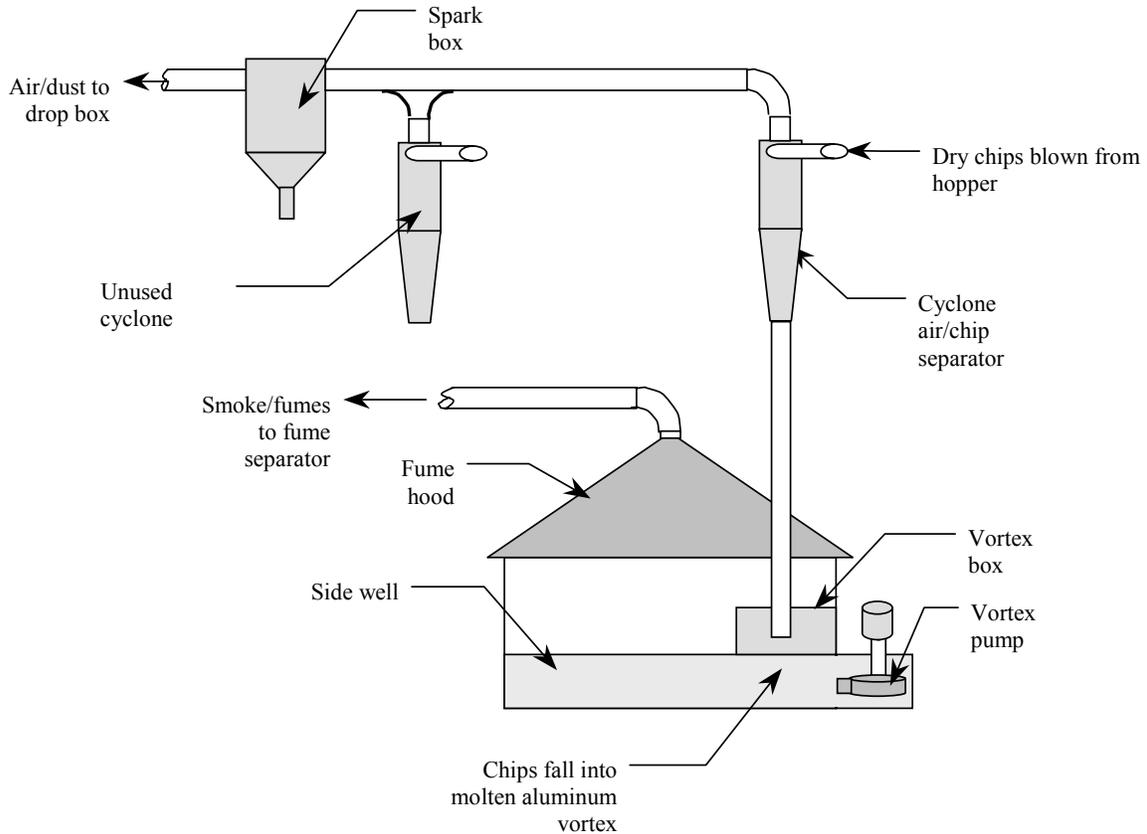
Figure 6. Diagram of furnace 5 chip feed.

At about 8:20 pm, three Hayes maintenance personnel restarted the dry chip feed system. Employees reported that after the restart, chips fed steadily to the furnace 5 sidewall for about 10 minutes. At that point one of the employees—who was standing on the north side of the furnace, about 10 feet from his coworkers —noticed chips falling out of the spark box (see Figure 6) in the dust collector duct.

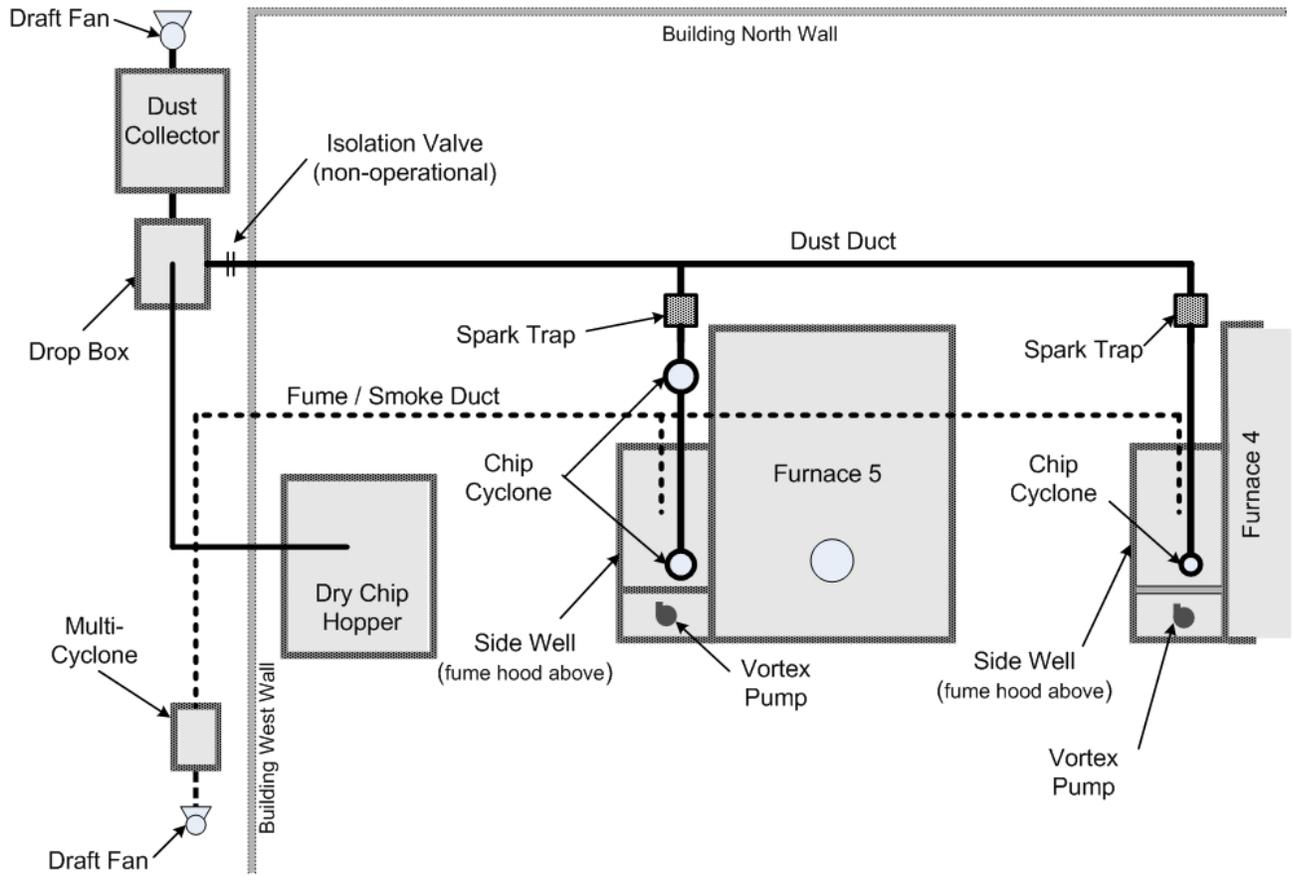
Figure 12. Layout of dust collection, furnaces, and ducts. Some ducts and equipment omitted for clarity.

A 6-inch pipe attached to the drop box roof and the dry chip hopper (Figure 12) provided a direct path for pressure to travel to the dry chip hopper and damage the access door. This pressure was sufficient to bulge the door of the dry chip hopper (Figure 18).

However, Hayes added a direct duct from the dry chip hopper to the drop box (see Figure 12) in an effort to vent what employees described as “positive pressure” within the dry chip hopper. In correspondence with CSB, Hayes opined that embers might migrate from the kiln dryer to the dry chip hopper. CSB believes that such an ember could have been pulled by the draft fan into the drop box.
